LEVEL 2 HOME SURVEY

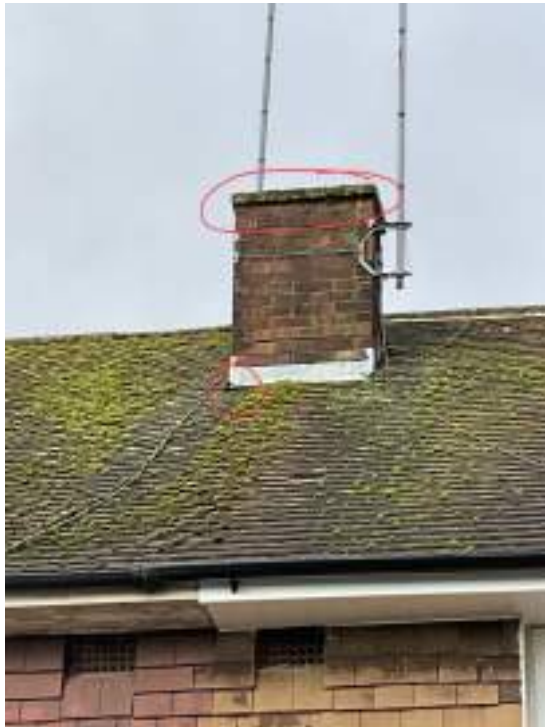
Minor defects noted

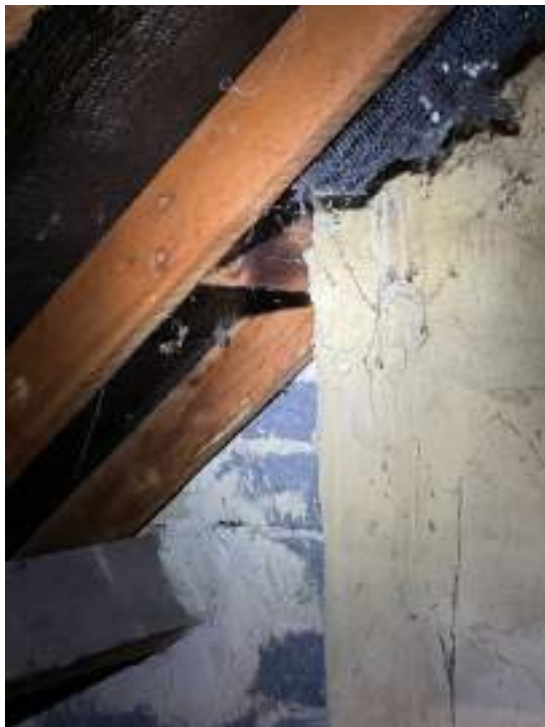
Slight rot to timbers

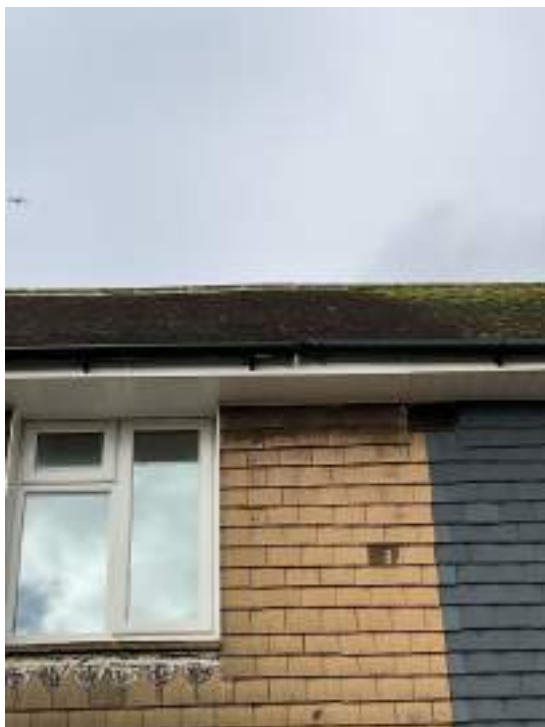
There is a general unevenness to the roof surfaces which is probably due to the displacement of roof timbers over a number of years. This is not an unusual defect in a roof of this age and it is unlikely to progress significantly.

Undulating roof

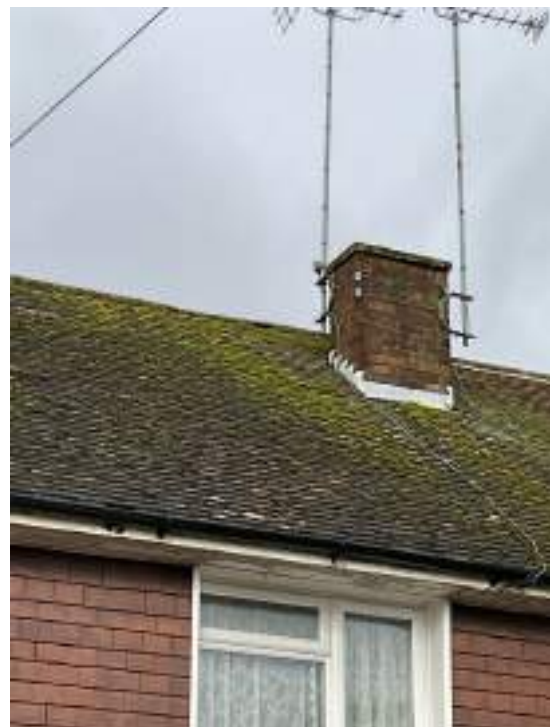
Ridge tiles loose neighbouring property

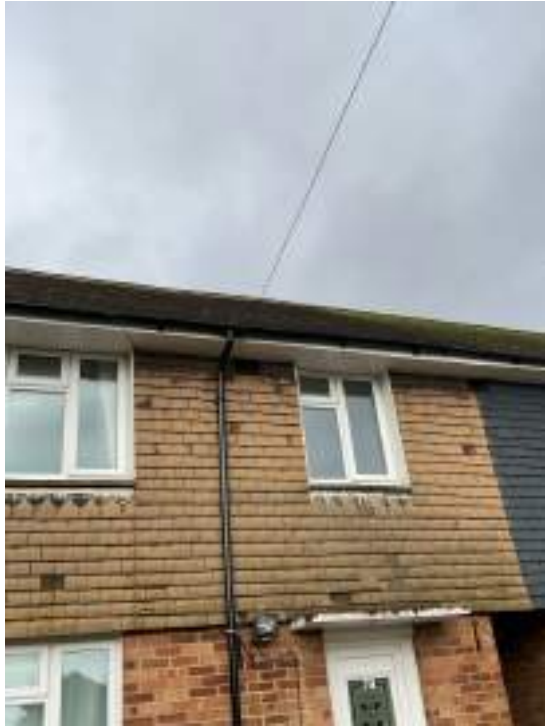
Undulating roof to right

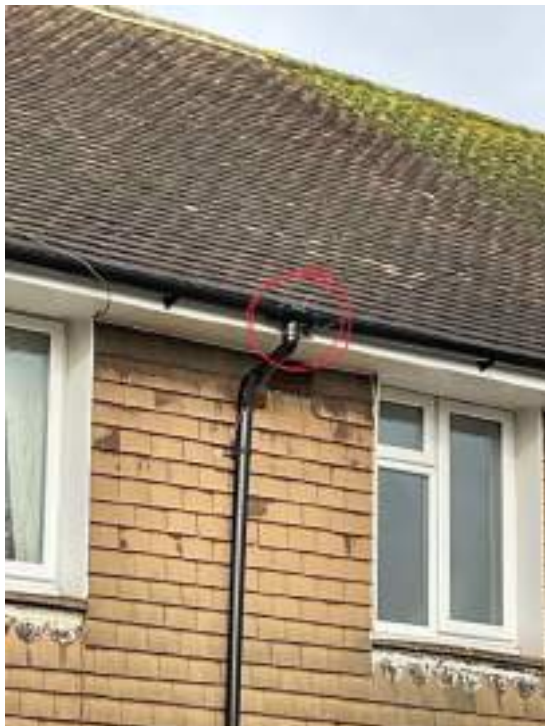
Blocked by vegetation Front elevation

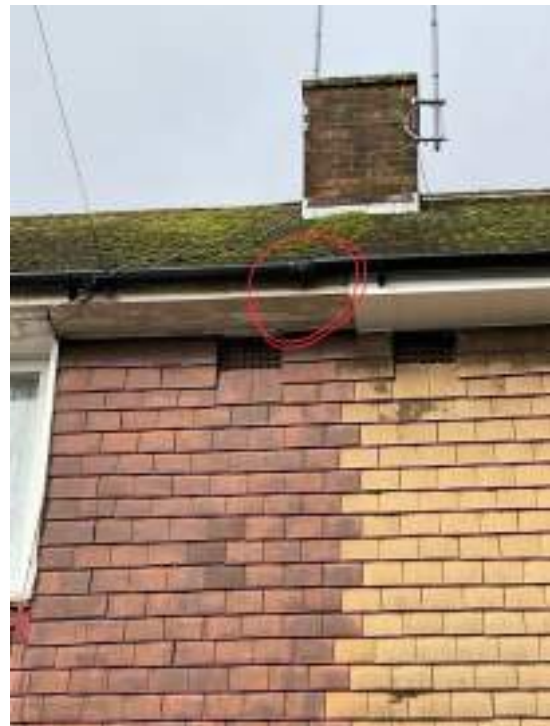
suspect joints, leaking joints, moss and lichen growth, loose sections, inadequate fixings and damaged sections. Repair, maintenance and improvement works are now required.

Leaking connection Front elevation

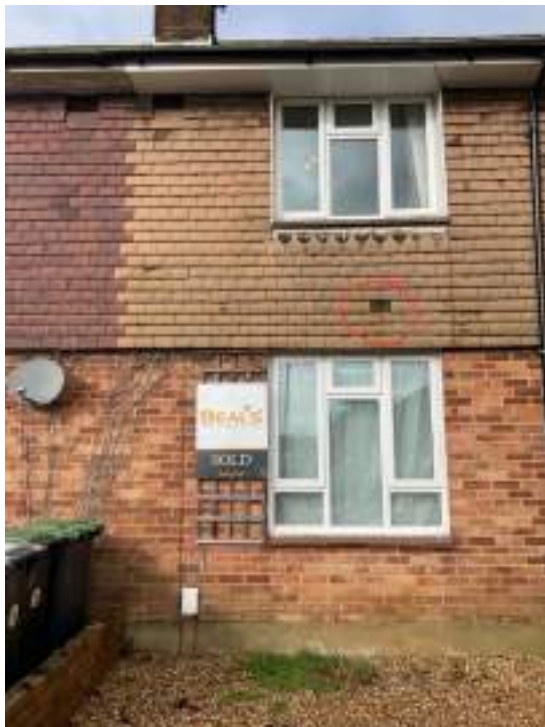
The tile-hung areas are in generally fair condition although there are slipped and missing tiles which need attention.

Missing tiles

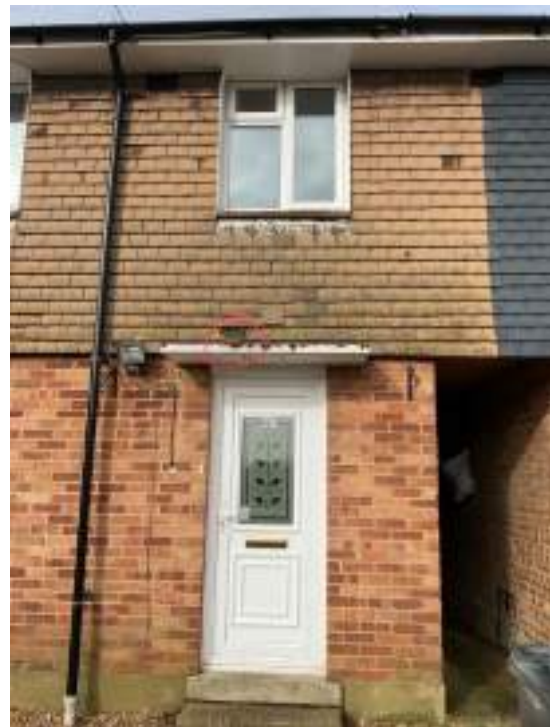
Missing tiles

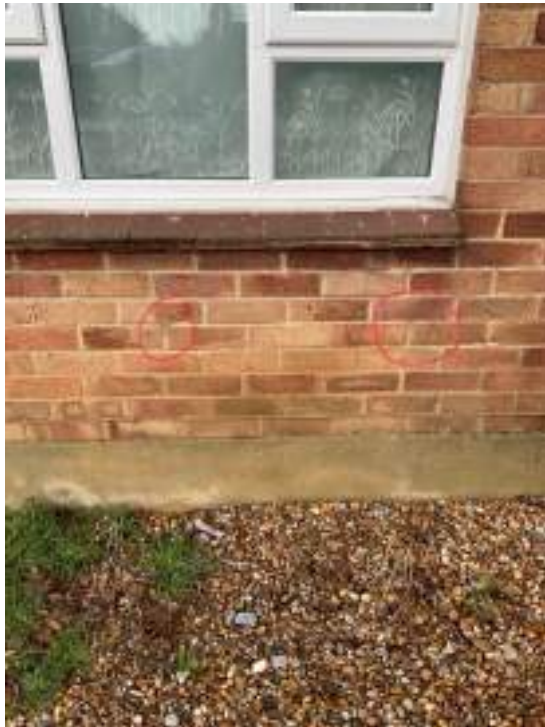
There is evidence that cavity wall insulation has been installed. Your legal adviser should make enquiries to verify the type of insulation and the existence of valid guarantees. In some circumstances, cavity insulation can cause damp penetration and/or result in accelerated corrosion of wall ties that will require remedial treatment.

Cavity insulation holes

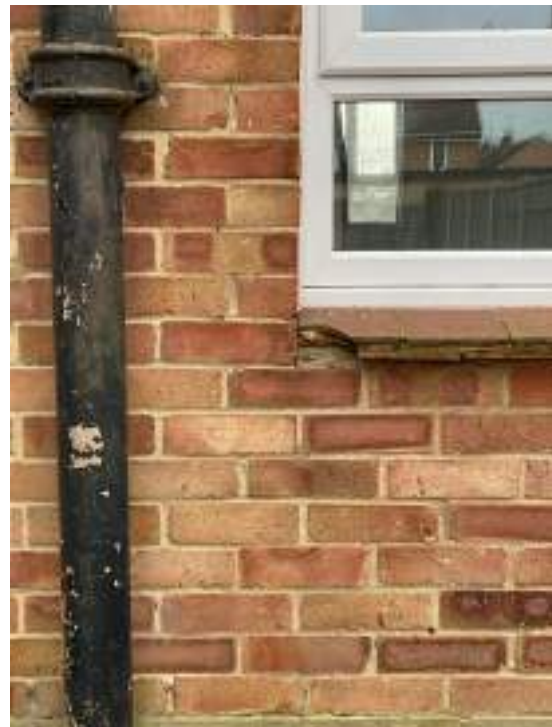
Damage to tiles

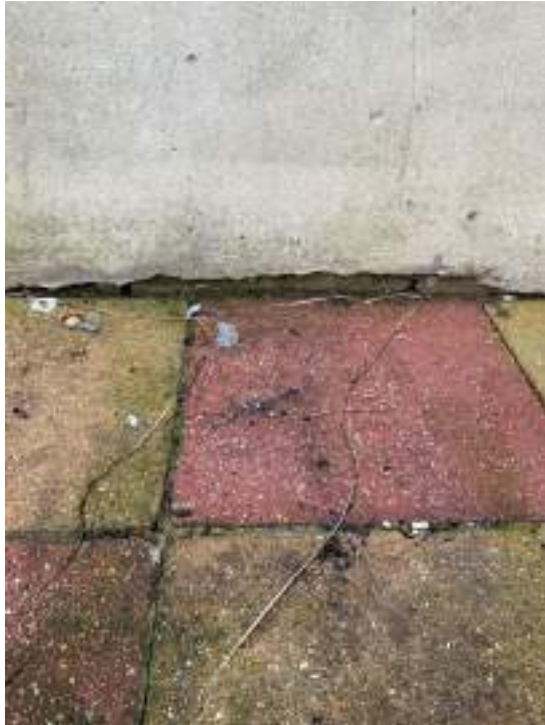
Cement plynth damaged this can leak in water repairs required

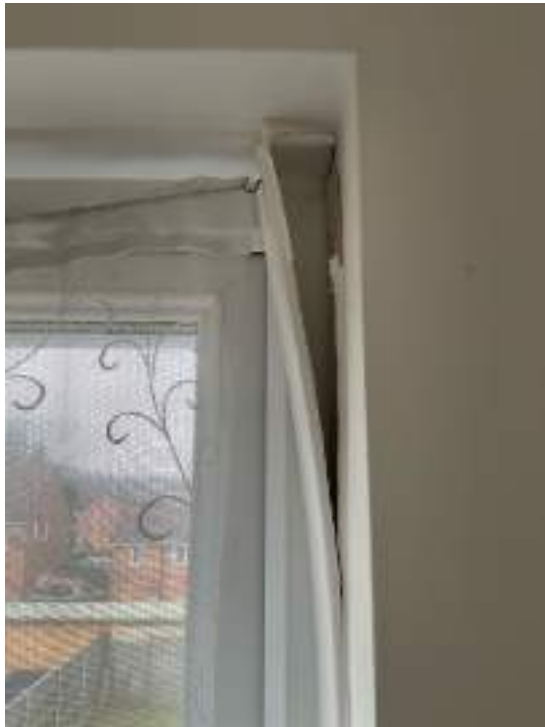
Trip damage

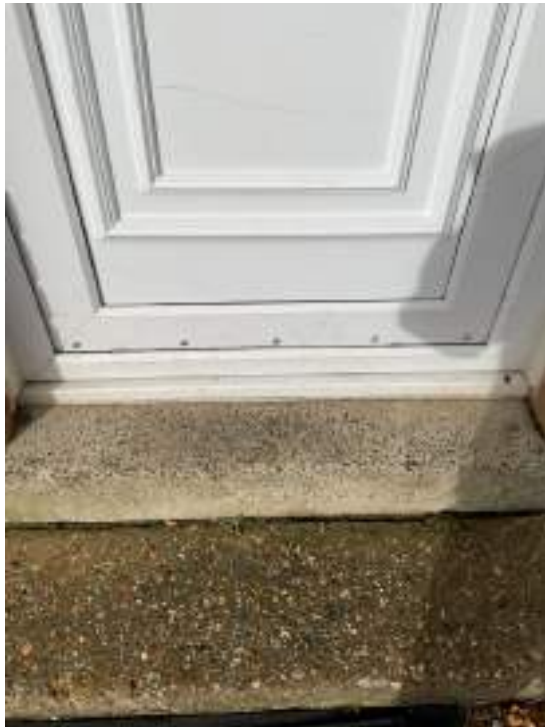
Weather guard missing

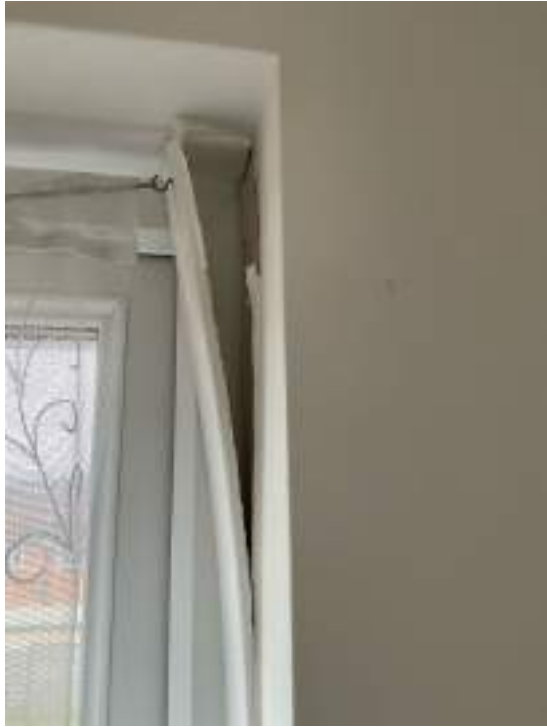
Damage to window internal

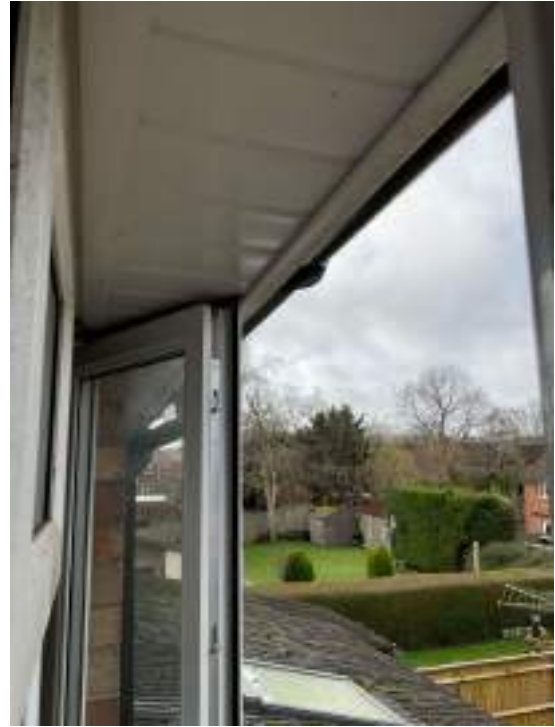
Some of the windows are binding on the fascia boards and preventing the full opening of the casement. This can be hazardous in the event of a fire and alterations are recommended.

Windows on FF unable to open

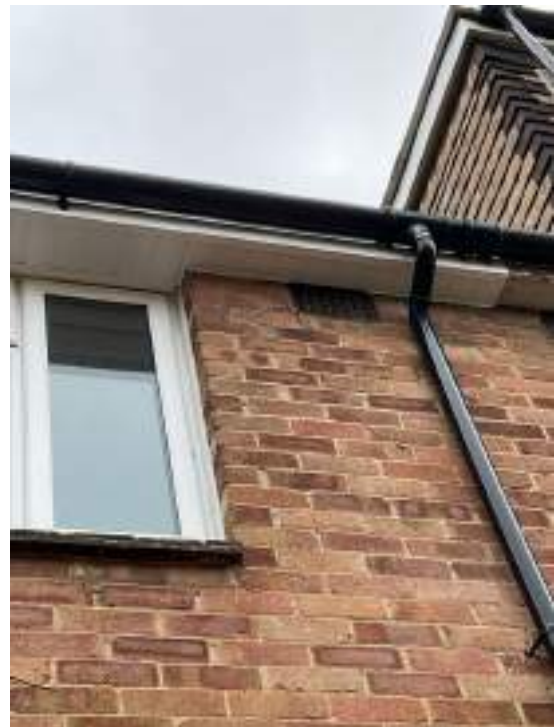
Not vented

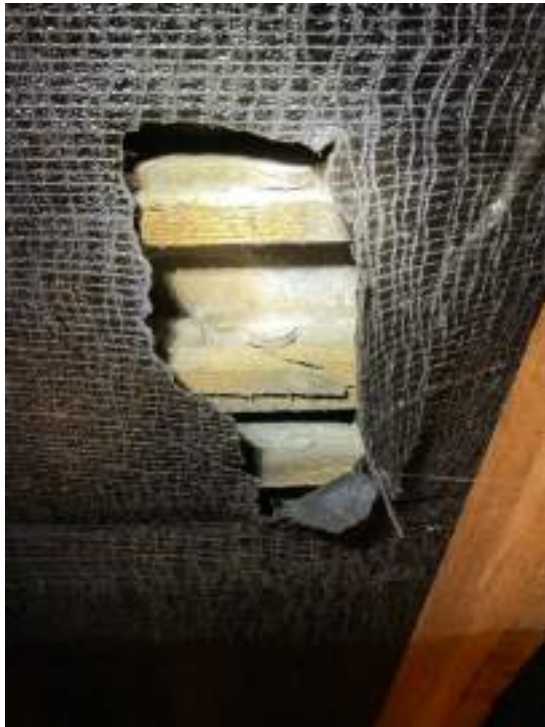
Within the limitations of the inspection, a number of defects/issues were noted, including torn felt were noted and repairs are now required. Obtain estimates, prior to purchasing.

The lining under the roof coverings is damaged in places. There is a risk of penetrating dampness and repairs are now required.

Battens cracked and torn felt

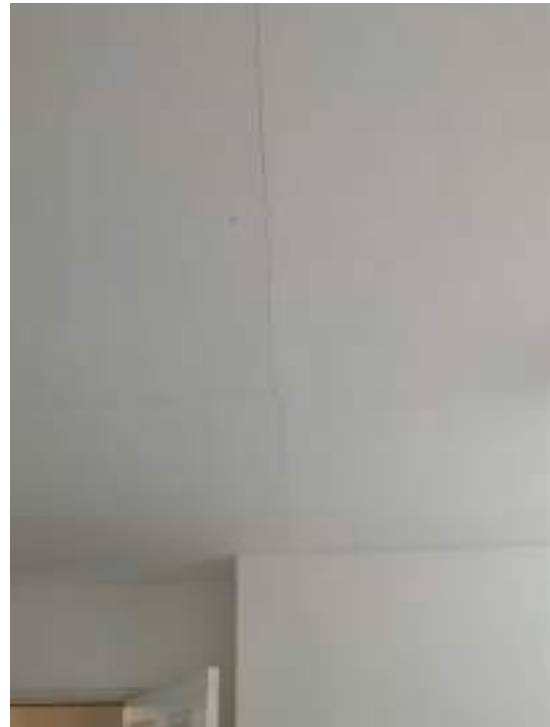
The ceilings are in a serviceable condition, however, localised areas of hairline shrinkage cracking were noted, which is a result of thermal changes in the building materials and is considered cosmetic in nature. These can be attended to during normal routine re-decoration periodically. These types of cracks are very common in a property of this age and type of construction and do not give cause for concern.

Hairline thermal cracks

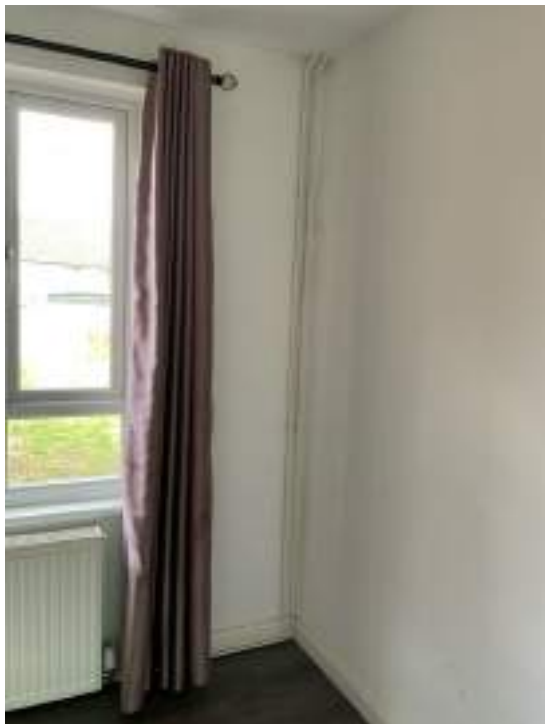
Exposed pipes can burn children and small pets

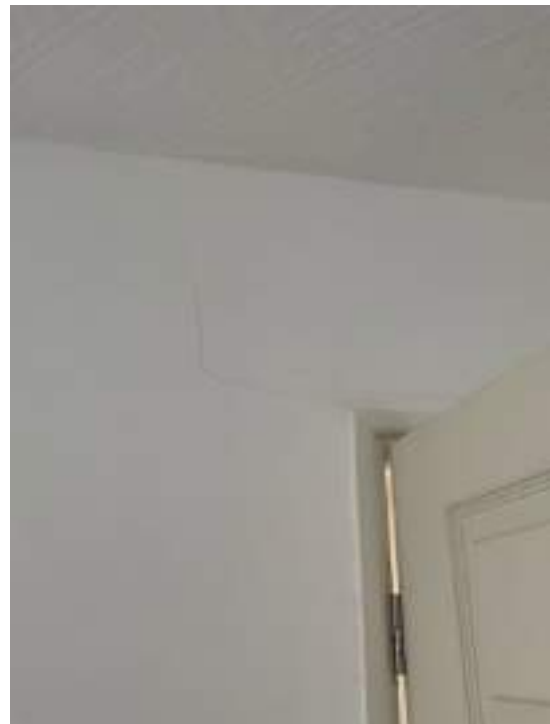
Hair line cracks

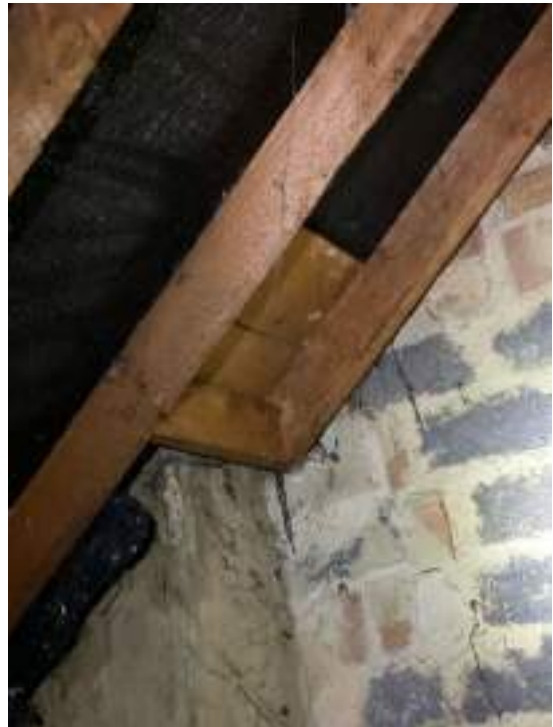
Breast in loft suspect area for leaks

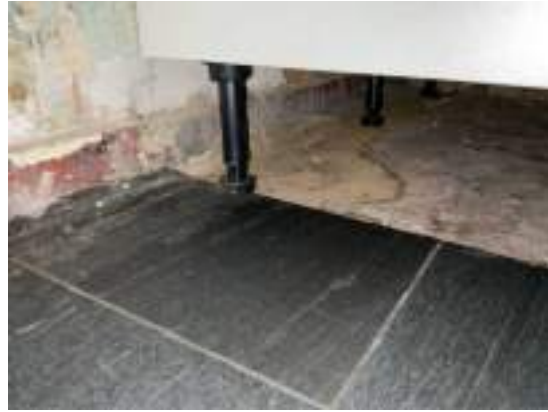
No stop cock found

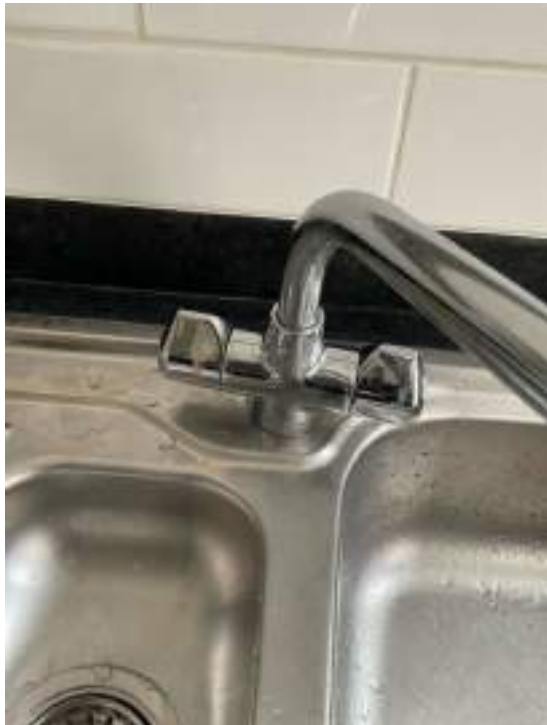
Loose tap fitting

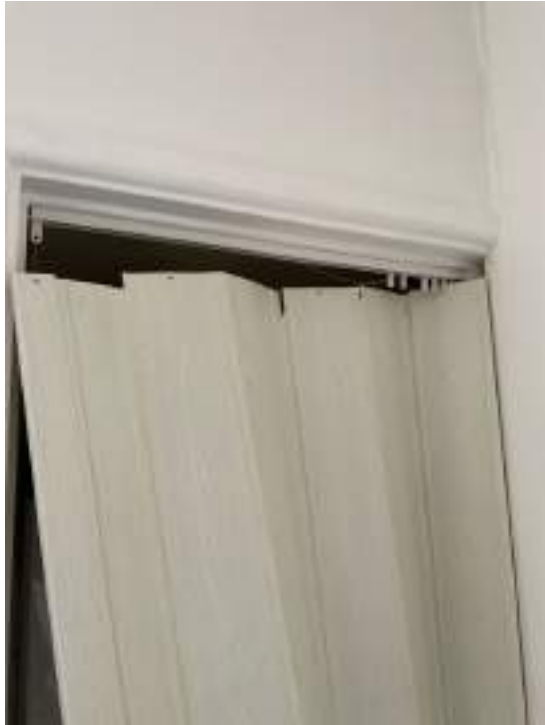
Door screen to boiler broken

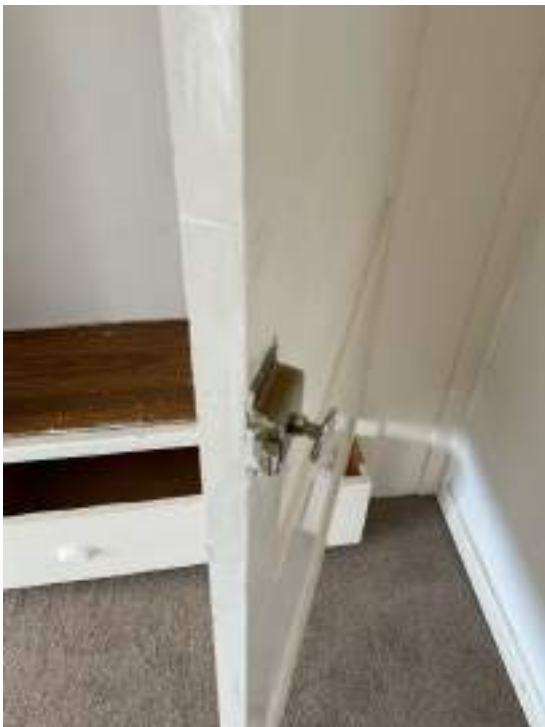
Bedroom cupboard lock handle broken

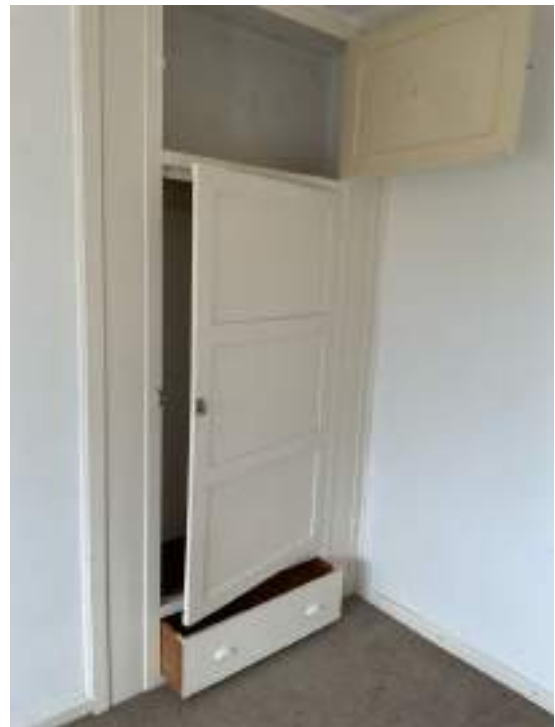
Broken handle

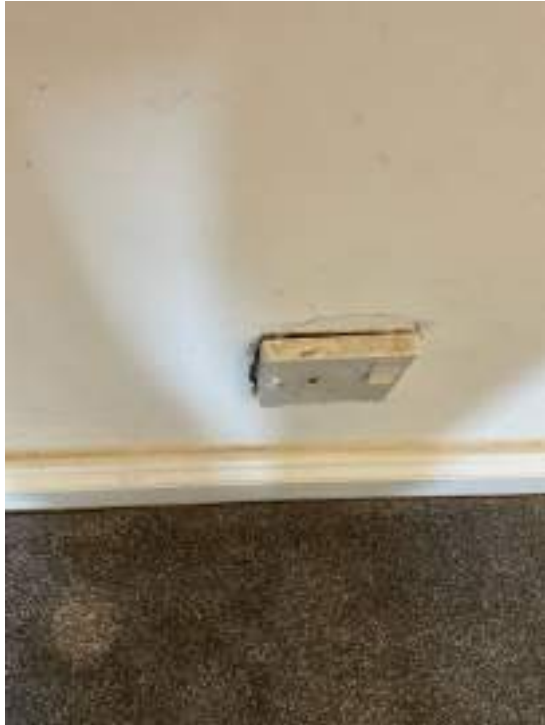
Loose fitted sockets

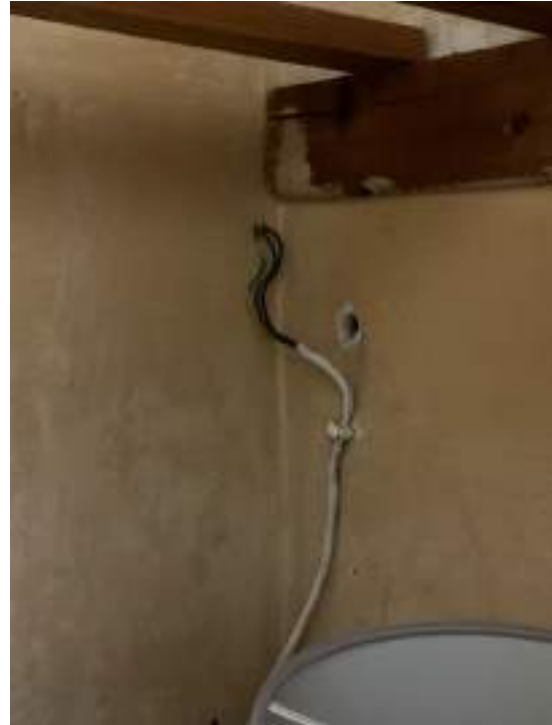
Wires in openings especially when required to be

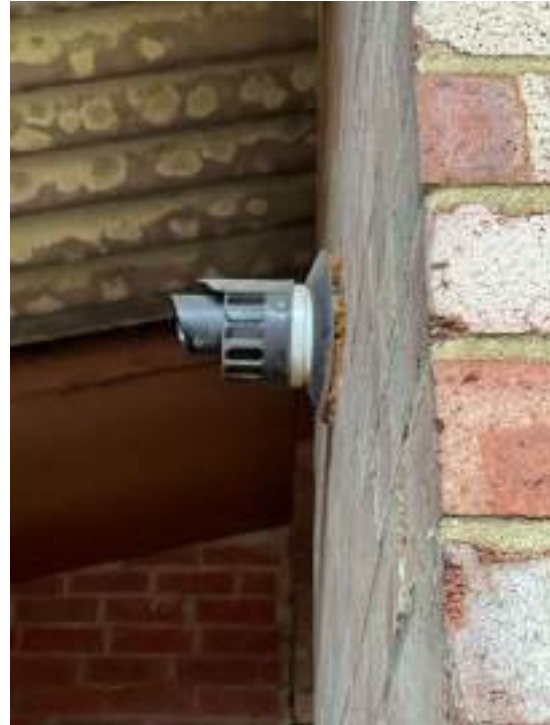
flue condition should be checked

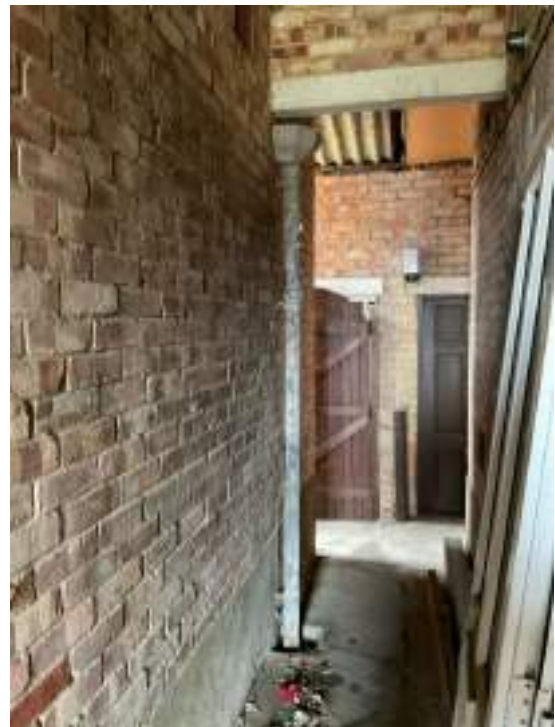
May contain asbestos fibres

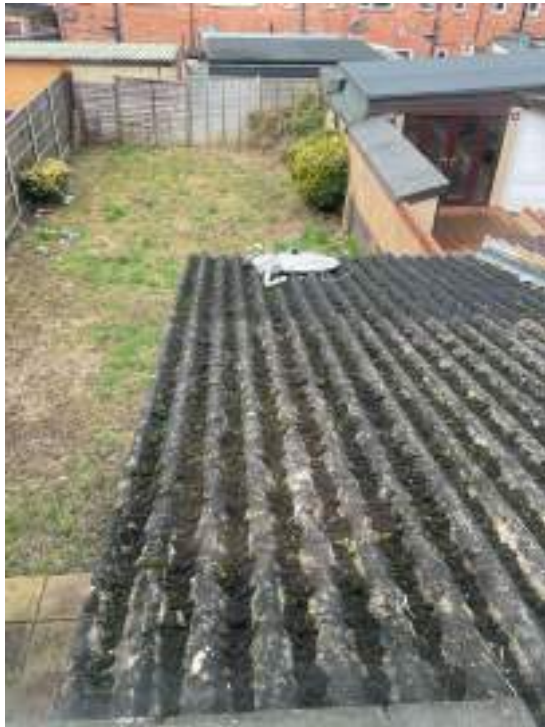
Parts of the stores are made out of material that may contain asbestos. These appear to be in satisfactory condition at present and should present no health risk if undisturbed. However, they should not be cut or worked in any way and specialist advice must be sought prior to being removed as this will prove costly.

Possible, asbestos corrugated roof

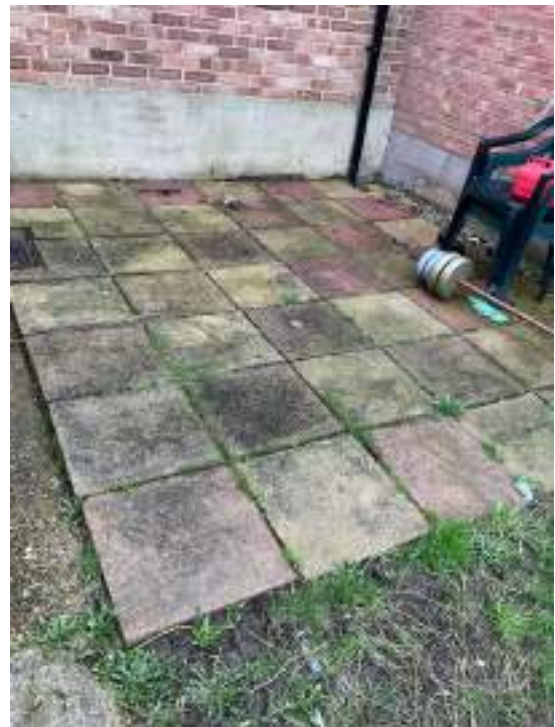
Various slabs, uneven

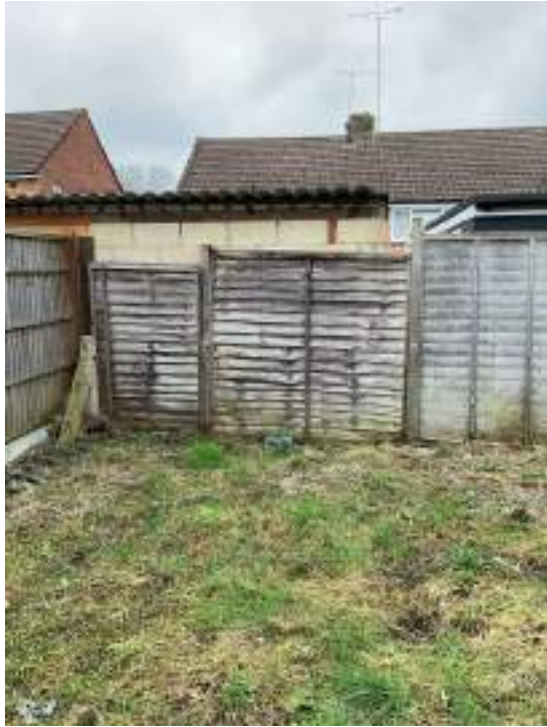
Fencing and garden needs to be replaced or redecorated

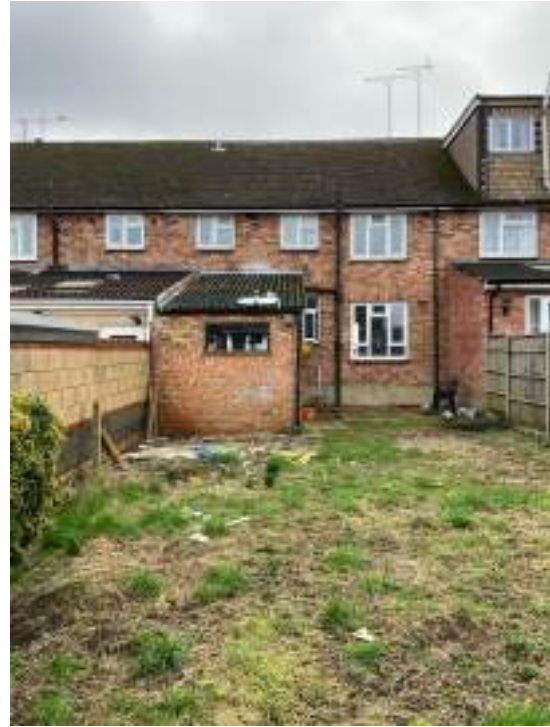
Asbestos roof to outbuilding
