LEVEL 3 BUILDING SURVEY

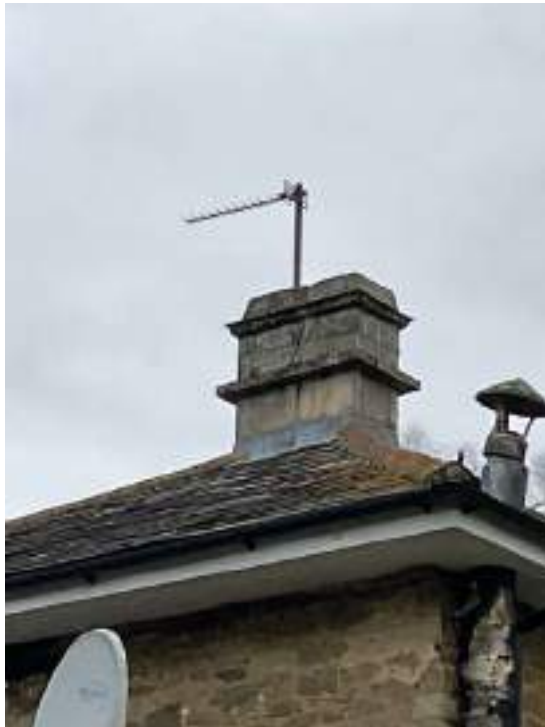
Stack to living room

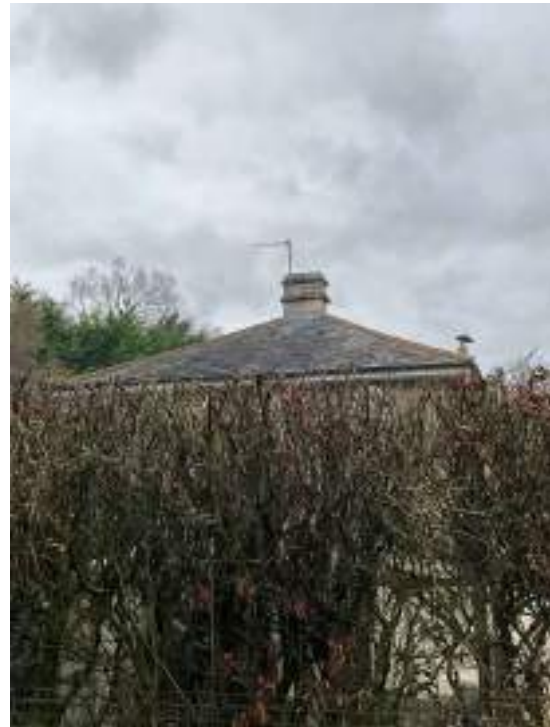
Roof and stack view and condition

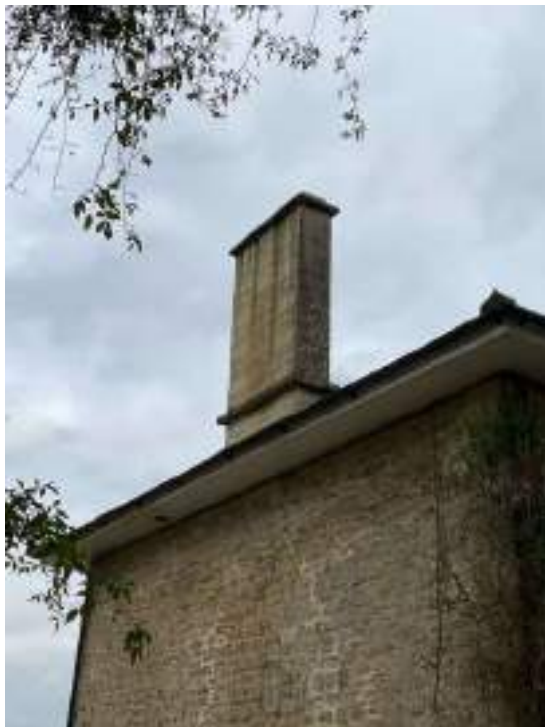
Kitchen stack condition

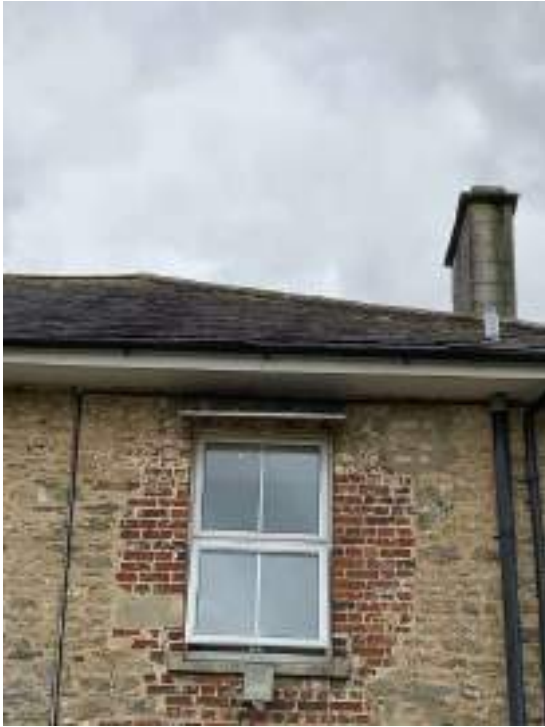
The covering was generally functional but we noted slipped slates. Repair and maintenance works

Consult a roofing contractor for costs to repair this section to the rear

We recommend that a certified roofing specialist is consulted to verify the above and below findings, and inspect any other possible defects in the roof and/or any chimney flue/stack in the immediate term, which are to be remedied as and when required, prior to exchange, purchase and occupation. Open joints in the tiling, notably at the ridge tiling, or slipped, cracked, or missing tiles may be present and should be remedied in the immediate term.

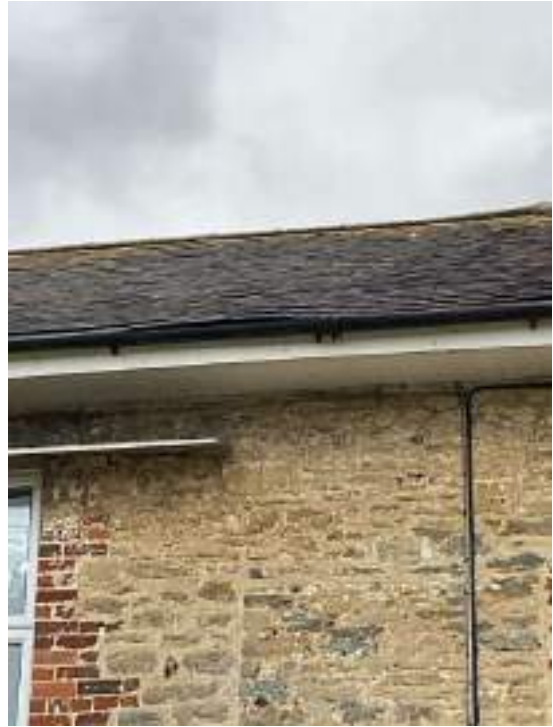
Lifted section of slates

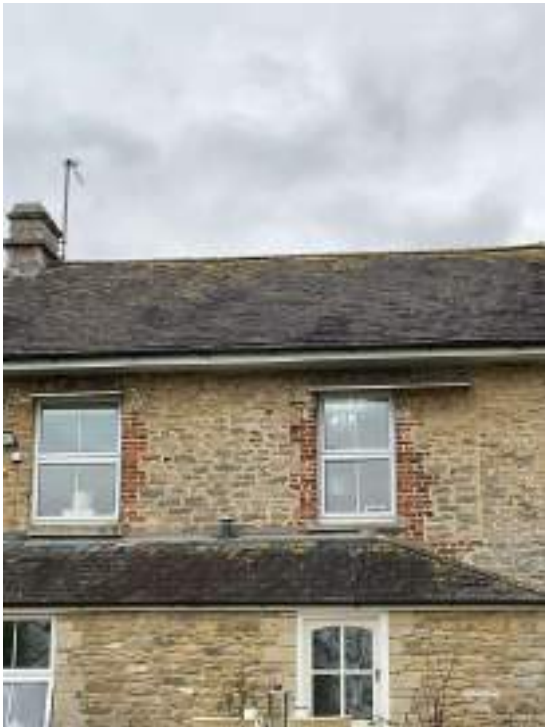
The bottom course of [redacted] have lifted which suggests the timber battens underneath have failed

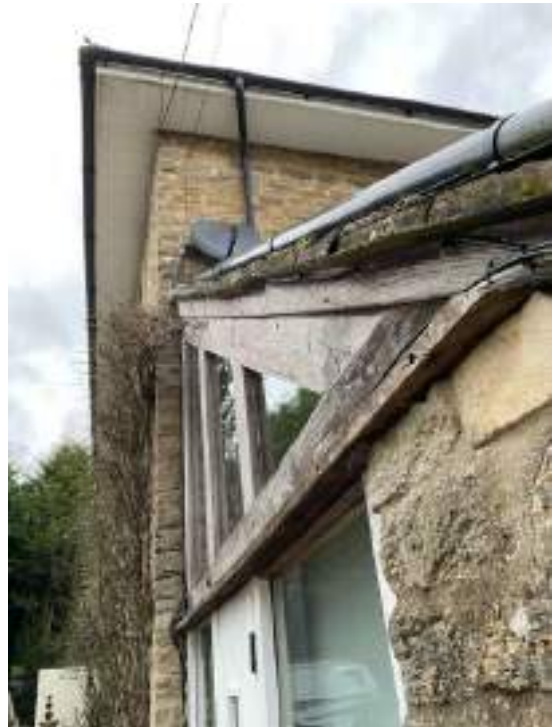
Undercloak board Possible asbestos containing material

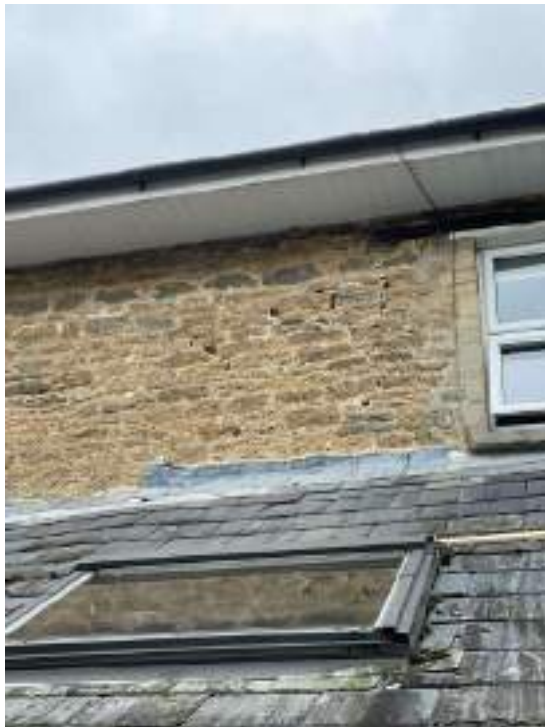
The overall condition of the walls were found to be adequate but some defects were noted, such as weathered pointing, holes to parts of the masonry walls and weathered finishes. Repair,

Side elevation will need re-pointed now

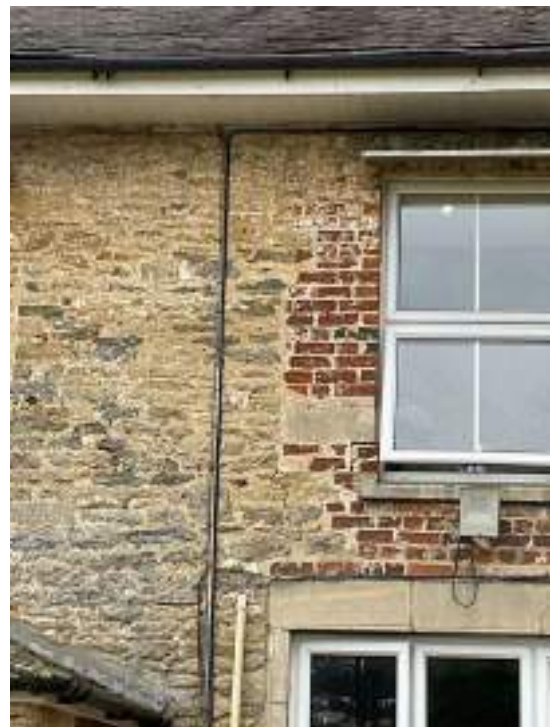
Minor cracks noted in places re-pointing required

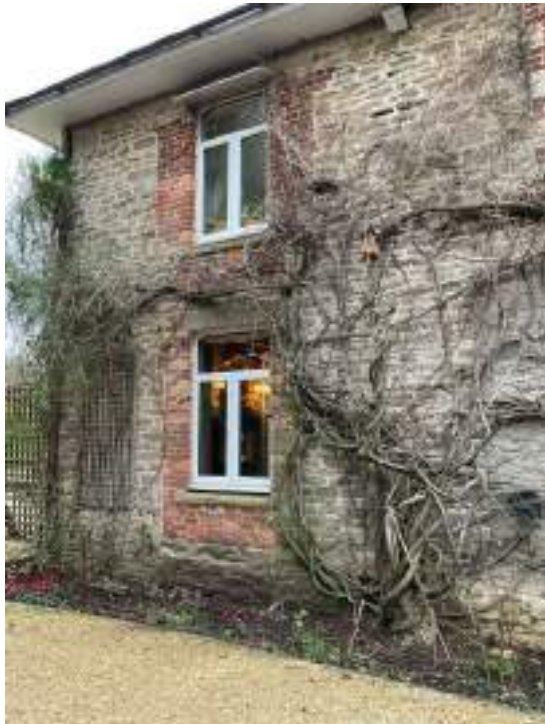
There is vegetation growth on or near to the house. Whilst this is unlikely to cause serious harm to the walls, it will be allowing moisture to be trapped against the wall which could cause deterioration and damp penetration. It is recommended that plants and shrubs be cut back to ensure that foliage does not project over windows, air vents, rainwater goods, etc.

Vegetation should be removed from the walls as they soak in moisture and cause damage to the building

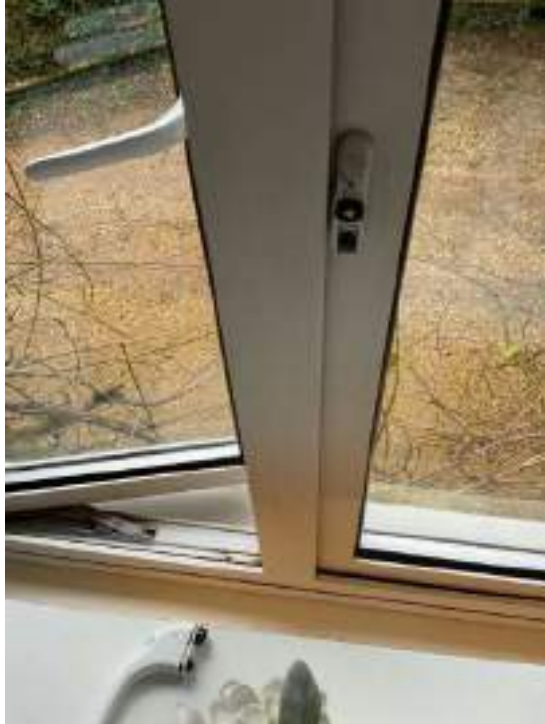
The installation appeared to be functional overall but defects were noted, such as loose handles and worn rubber seals. Repair, maintenance and improvement works are now required.

Handle broken off when testing

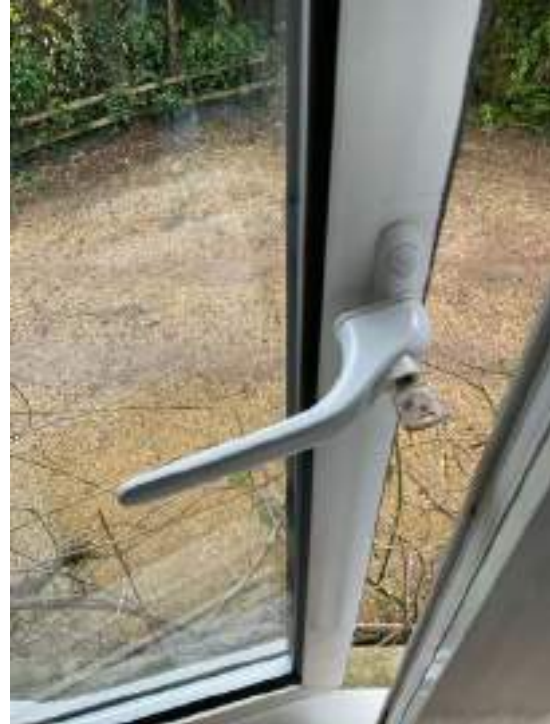
Loose handles

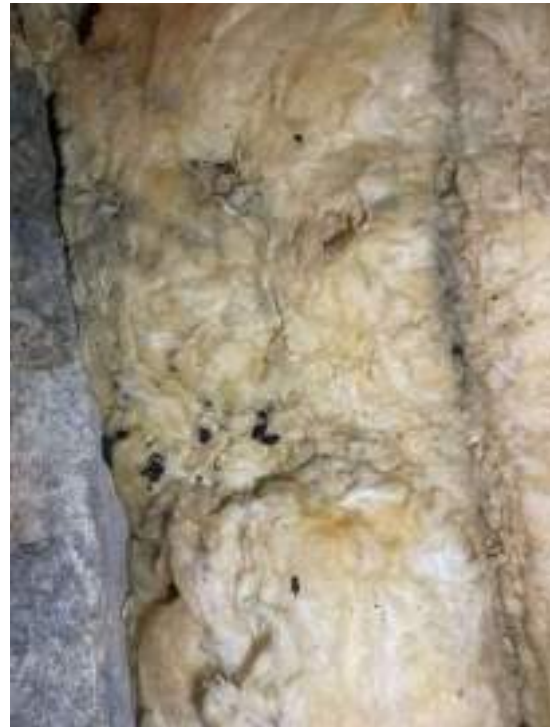
There is evidence of rodents in the roof space. Mice, rats and squirrels can cause serious damage, particularly if they chew through electrical cables. Further advice should be sought from the Environmental Health Department of the local authority for eradication and future control.

Vermin droppings

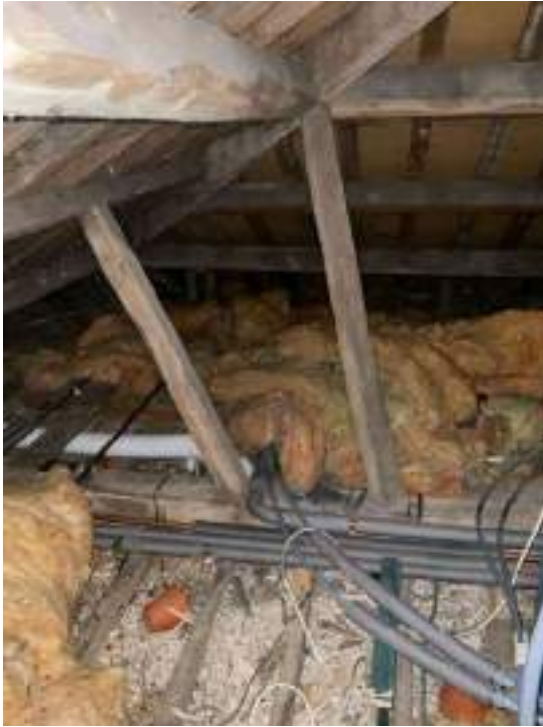
Insulated pipes, areas left un-insulated can cause cold bridging

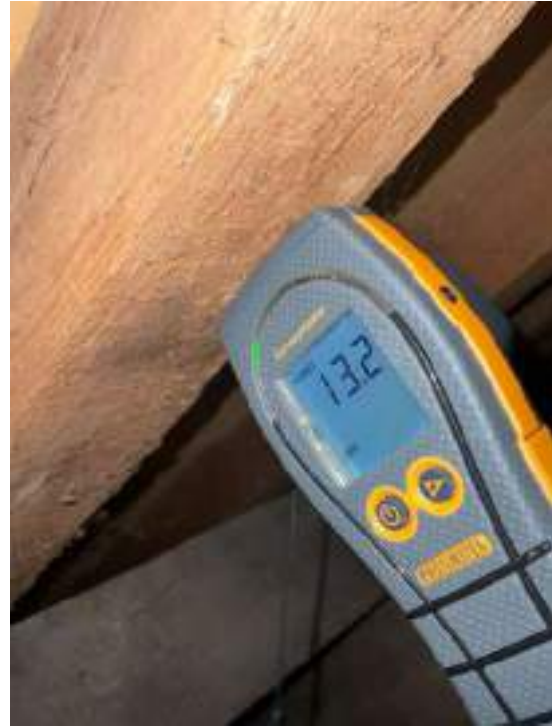
Timbers are dry

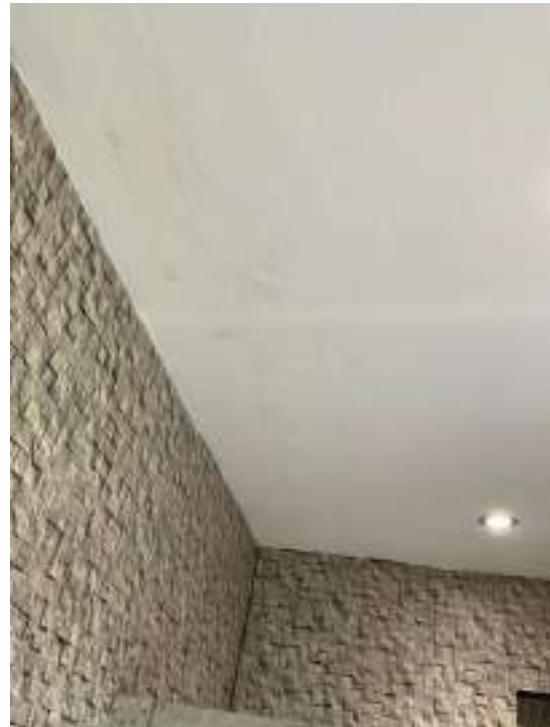
Minor re-decoration required

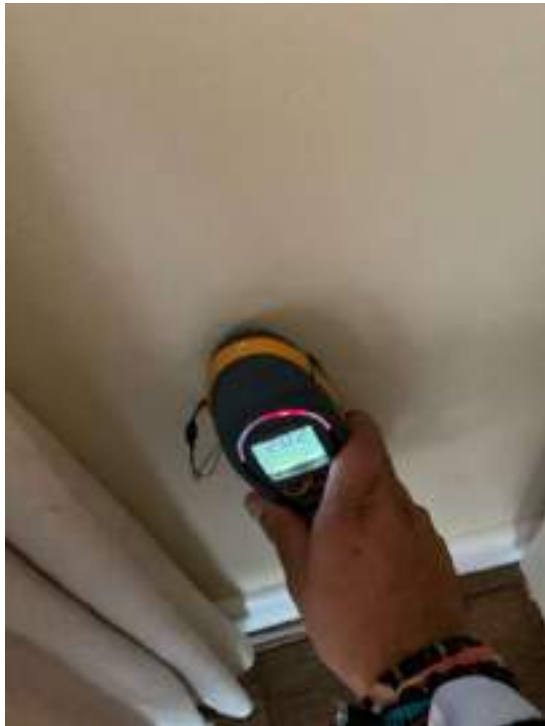
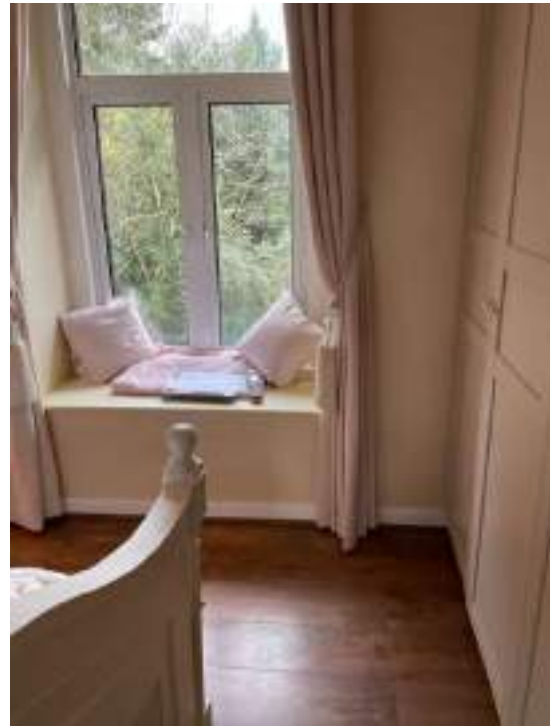
Numerous moisture meter readings taken throughout the property indicated isolated areas of raised damp content affecting ground floor walls at low level. This has to be accepted as a

Areas of higher readings to master bedroom walls around the window

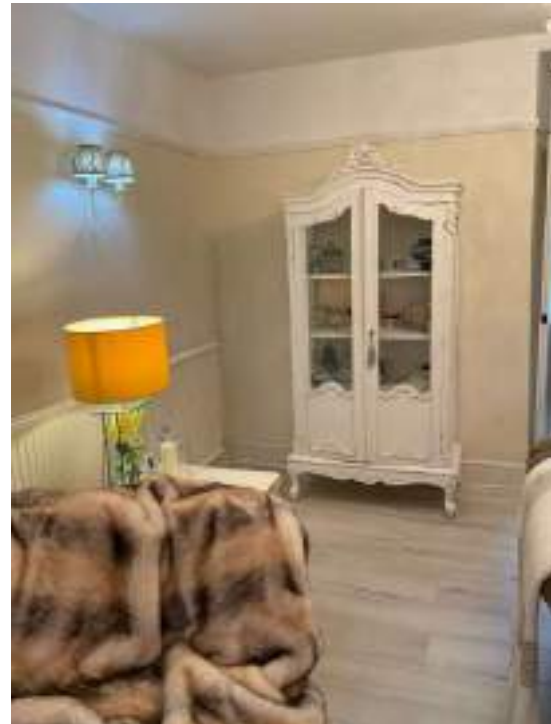
Dehumidifiers would be beneficial

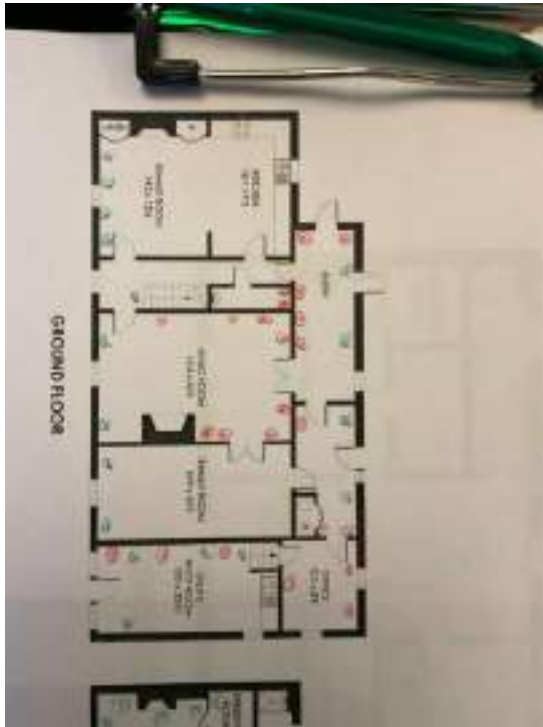
Ground floor red cross indicated damp readings

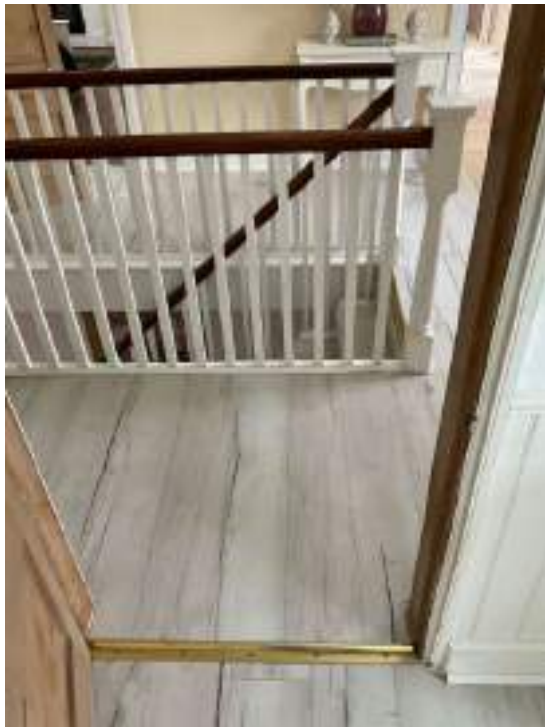
Slight spring and deflections to the first floor

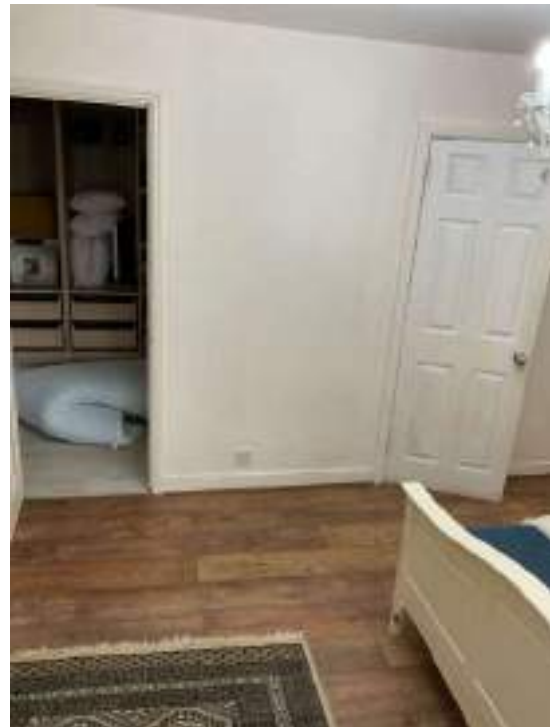
Slight spring and deflections to the first floor

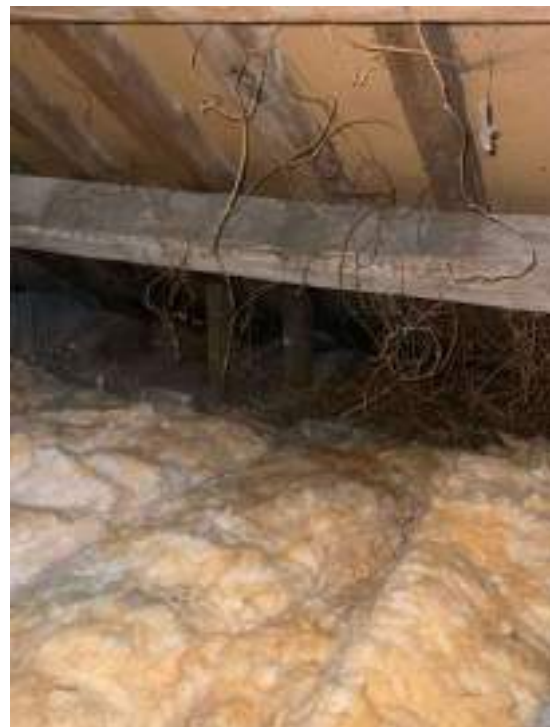
Vegetation in the loft

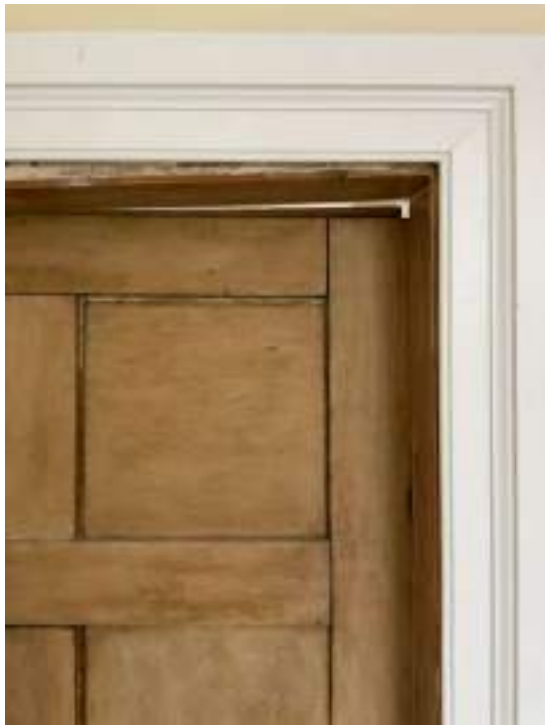
Some doors are not close fitting

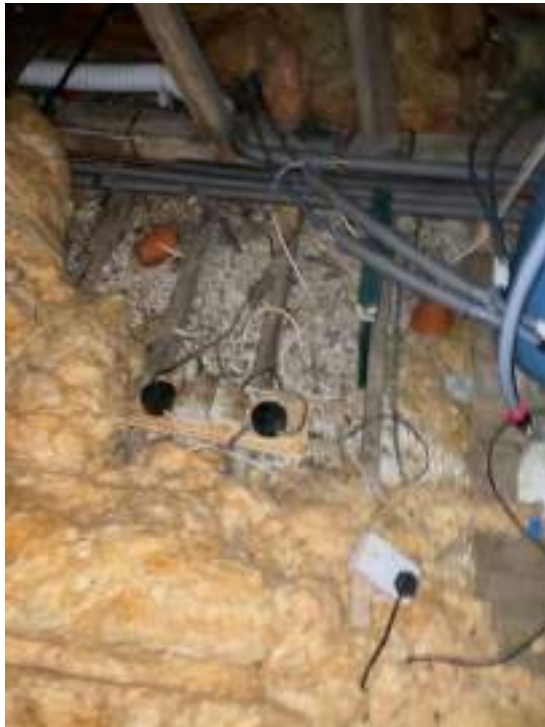
Where visible the electrical wiring is of a PVC-sheathed type. In places, it has been buried beneath loft insulation. This can cause overheating of the wires which could lead to fires. All covered cables must be re-positioned on top of the insulation.

Electrics to the loft need covered

You should ensure that your electrician checks the electrics within the loft area as part of the overall system inspection.

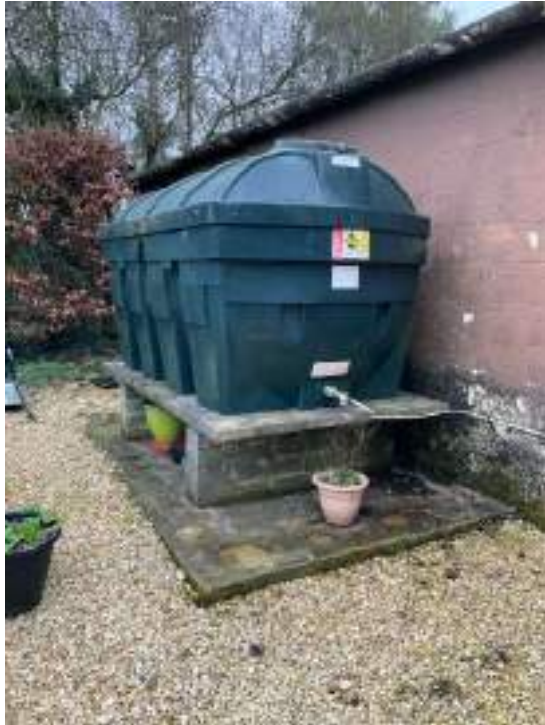
Although I could see no problems with the existing tank, it is older, has a single skin (modern ones have a double skin) and no secondary containment. Given the age, defects may occur in the near to medium term and therefore, if you want to be sure, you should ask an appropriately qualified person to inspect the oil installation system with a view to upgrading before defects with the existing tank become apparent.

Oil tank in the garden

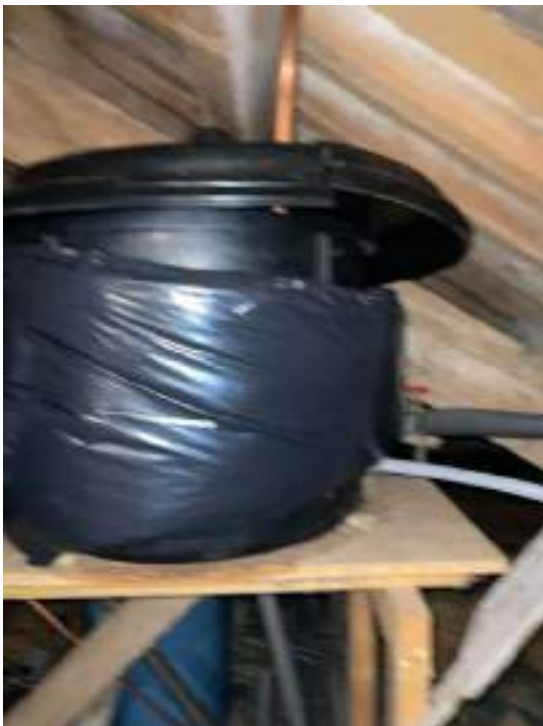
Loose covers - these need to be secure

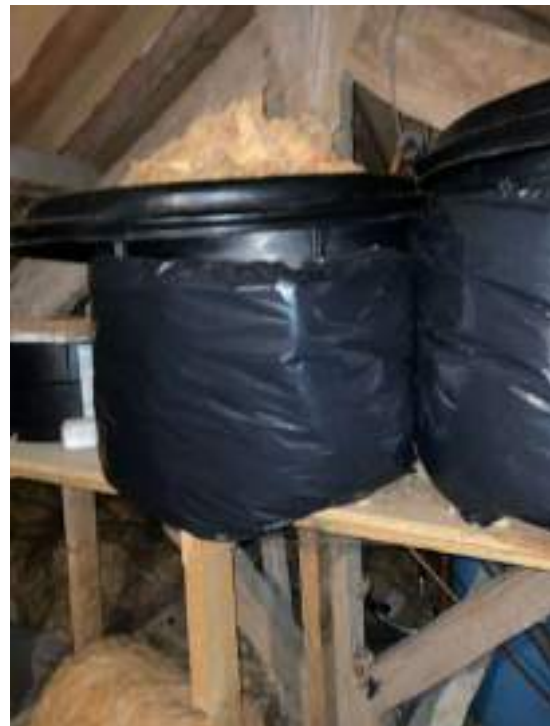
Loose fitting lids need to be replaced

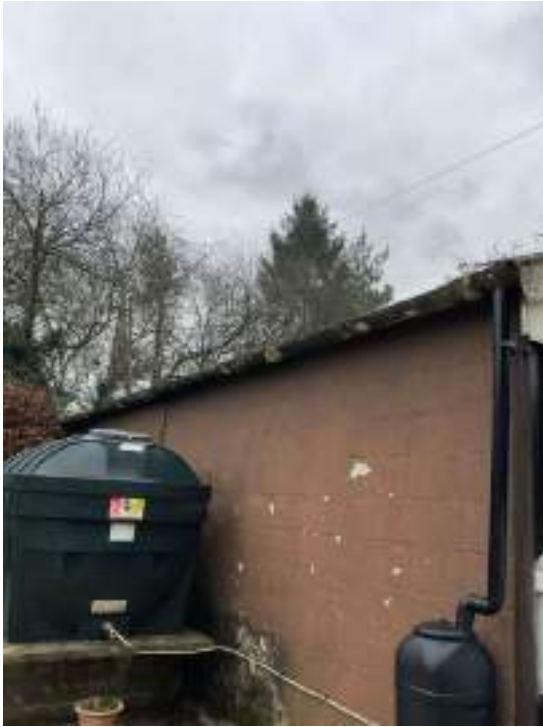
Parts of the garage are made out of material that may contain asbestos. These appear to be in satisfactory condition at present and should present no health risk if undisturbed. However, they should not be cut or worked in any way and specialist advice must be sought prior to being removed as this will prove costly.

Possible asbestos containing material

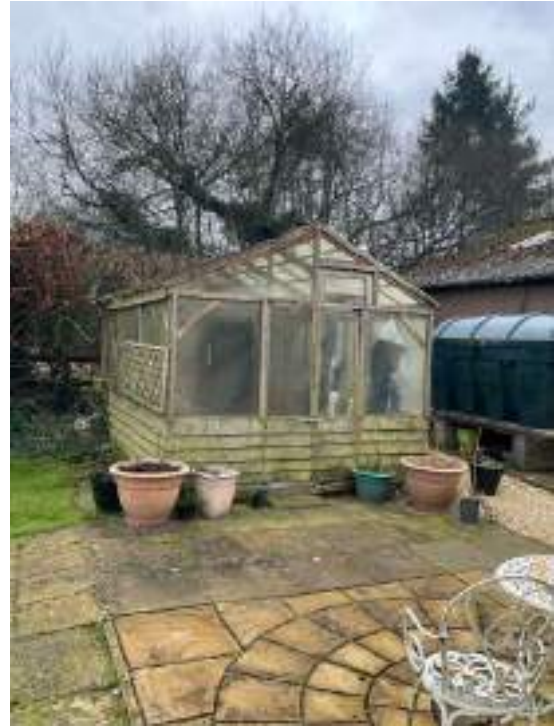
Conservatory in poor condition

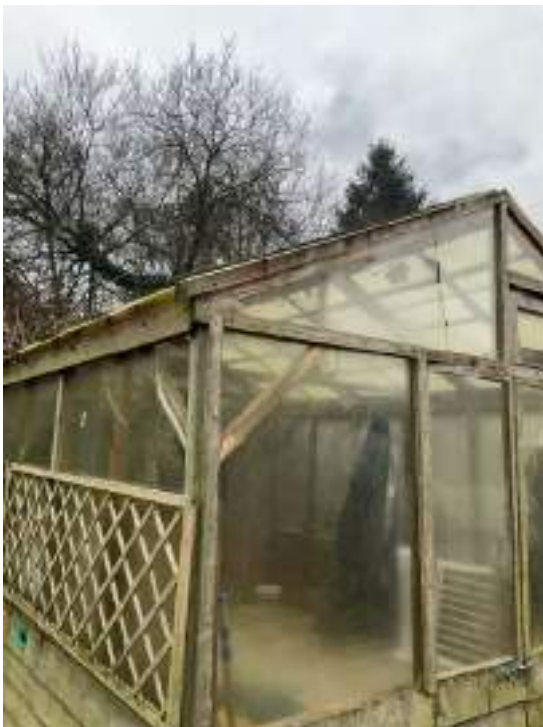
torn panels

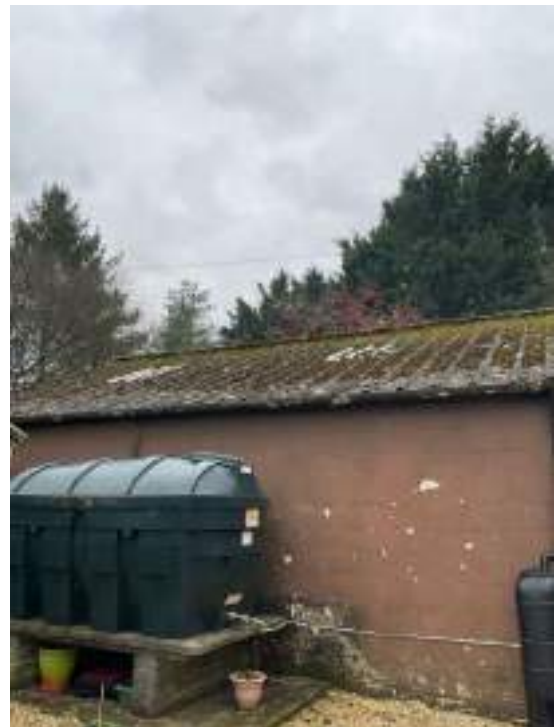
Possible asbestos containing material

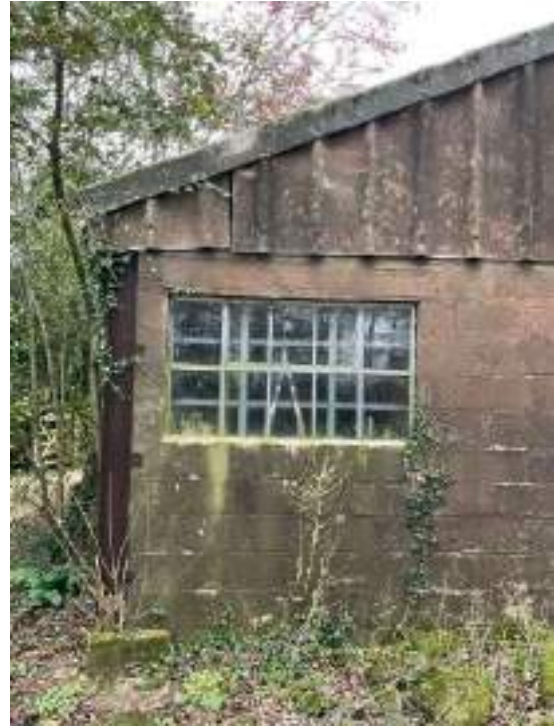
No safety glass

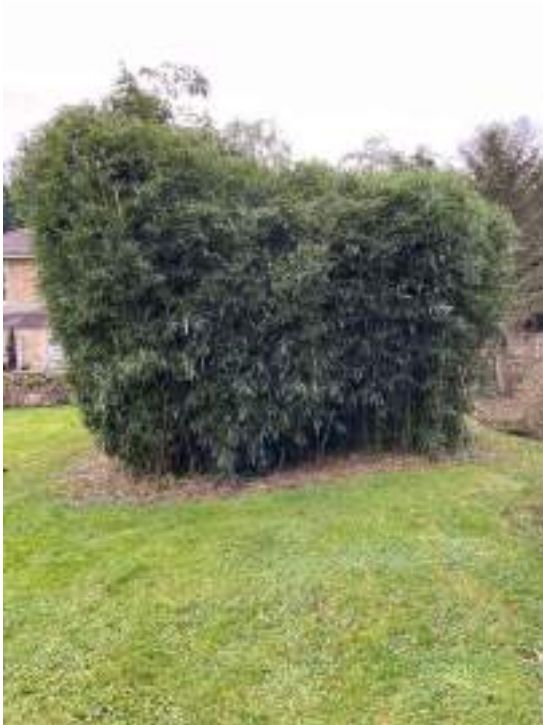
Bamboo we advise this is removed
