Project Report

Section Video:
mh1_

Start: Mh1
Pipe line Size

End:
Stack pipe

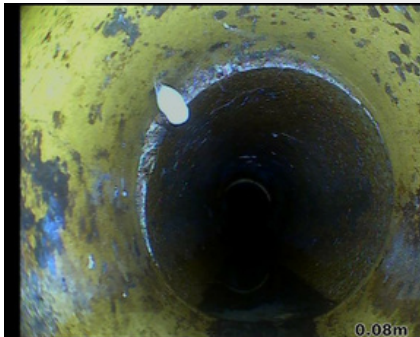
Observation [3]:
Joint displacement and cracking

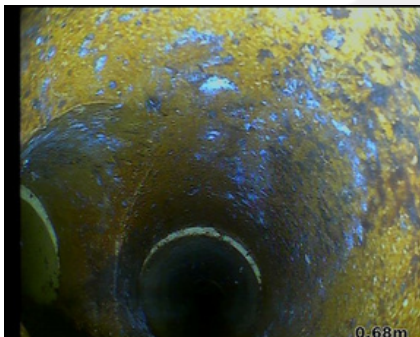
Observation [4]:
Left hand lateral connection

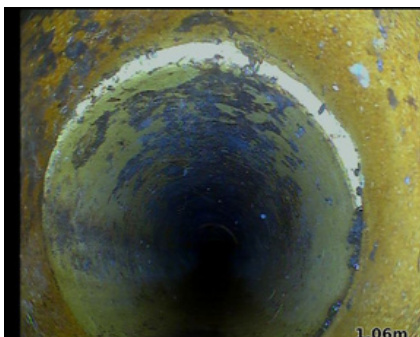
Observation [5]:
Joint displacement

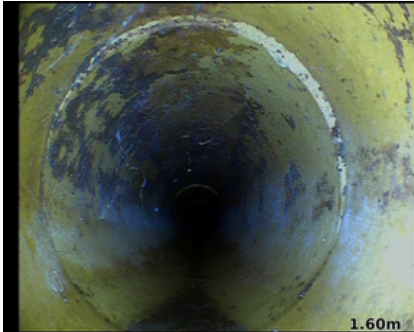
Observation [6]:
Joint displacement

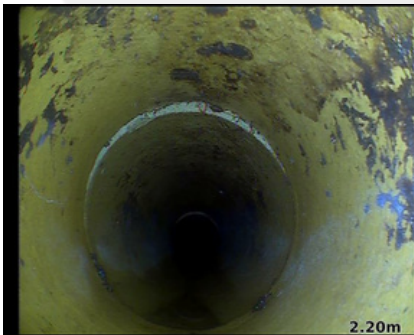
Observation [7]:
Joint displacement

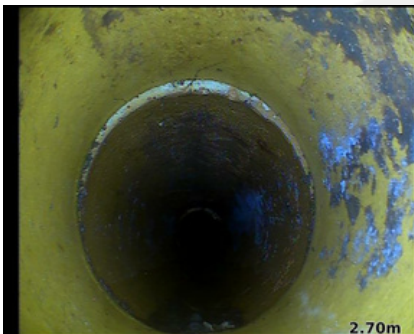
Observation [8]:
Joint displacement

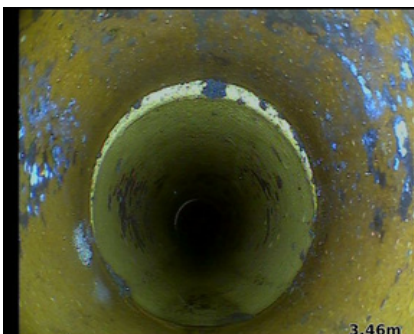
Observation [9]:
Joint displacement

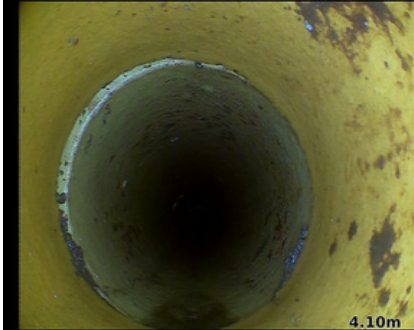
Observation [10]:
Joint displacement

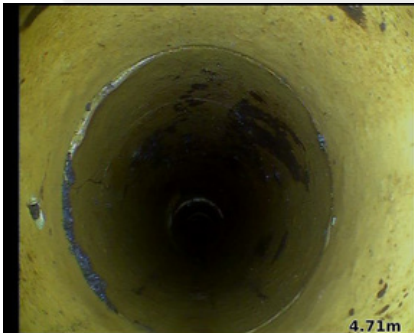
Observation [11]:
Damage at 9 o'clock

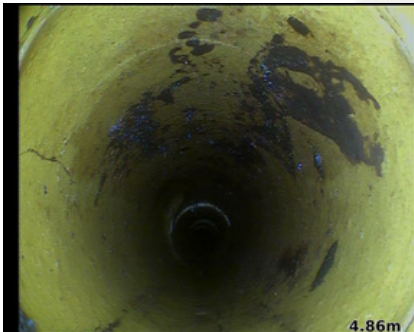
Observation [12]:
Cracking from 12 o'clock

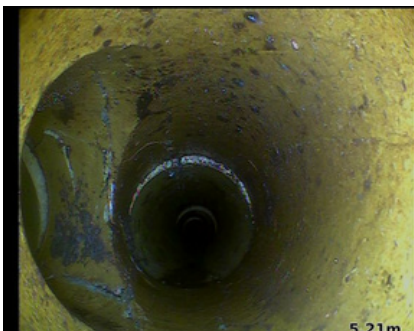
Observation [13]:
Left hand lateral connection badly cracked

A significant joint displacement was found at the base of the soil vent pipe. This defect would require a local excavation to expose the pipe and carry out a repair, as trenchless methods (such as lining) cannot reposition displaced joints effectively. Left-Hand Lateral Connection (towards gully) Severe cracking and damage were noted at a lateral 'Y' connection. This section requires excavation and replacement of the damaged junction with a new, structurally sound connection. Buchan Trap (rear garden) The trap is heavily infiltrated by roots, and there is no long-term solution other than excavation and removal. Replacing the trap with a straight through pipe section would prevent roots from regrowing. The extent of root ingress and any trapped debris at the base of the trap cannot be fully confirmed until excavation is carried out. Rear Garden Gullies Both gullies appear to be blocked with silt and debris. These require manual clearance and high pressure water jetting to remove obstructions from the gully pots and u-bends. Once cleaned, further inspection should be undertaken to check for any hidden structural damage. Front Downpipes (at the property frontage) Two gutter downpipes currently discharge directly at the base of the property, with no proper drainage system in place. This can cause water to accumulate against the building, leading to damp issues and, in the worst cases, long-term foundation damage. It is strongly recommended to redirect these into a suitable drainage system or a newly installed soakaway.

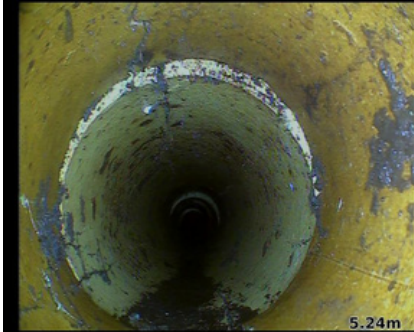
Observation [14]:
Joint displacement and cracking

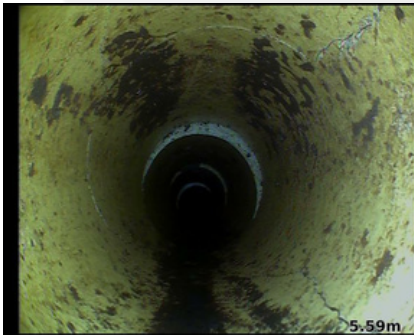
Observation [15]:
large cracking

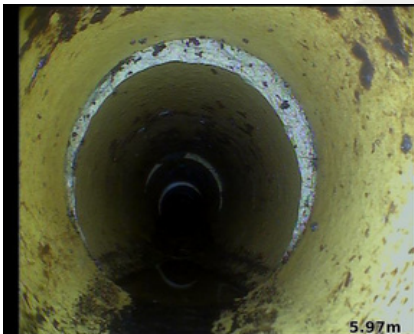
Observation [16]:
Joint displacement

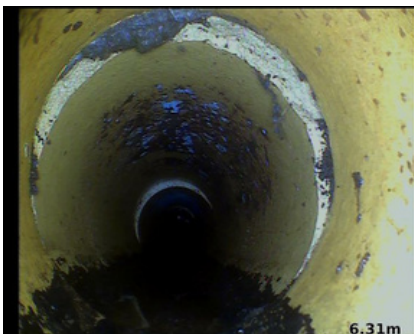
Observation [17]:
Joint displacement

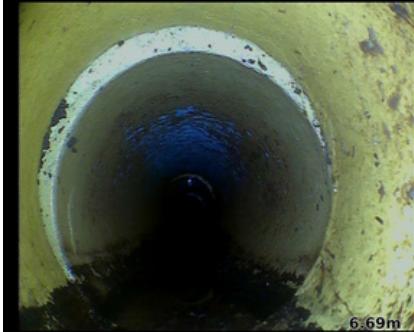
Observation [18]:
Joint displacement

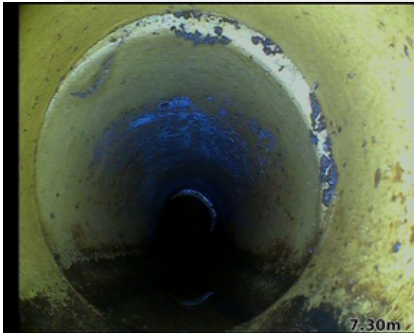
Observation [19]:
Joint displacement

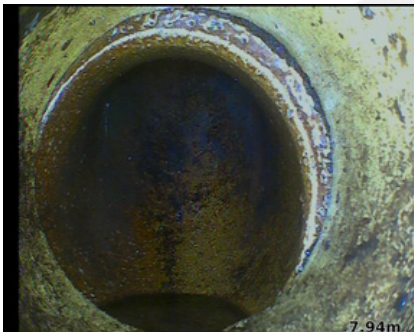
Observation [20]:
Joint displacement

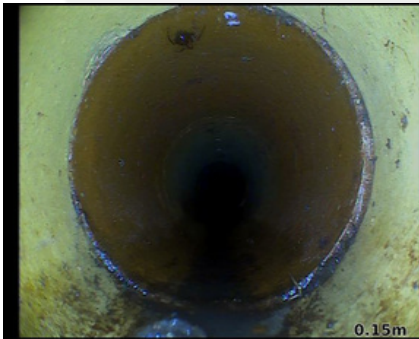
Observation [3]:
Joint displacement

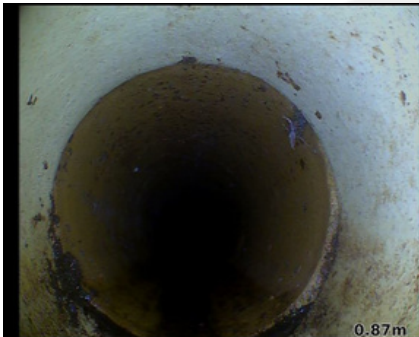
Observation [4]:
Joint displacement

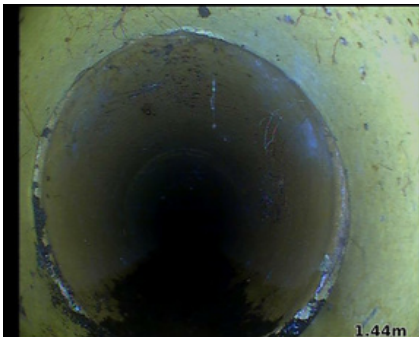
Observation [5]:
Joint displacement

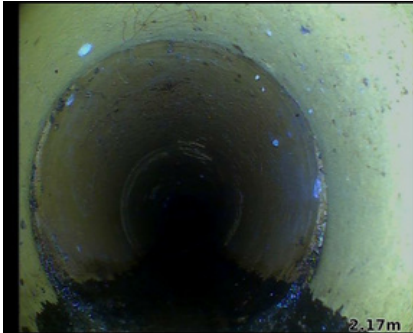
Observation [6]:
Joint displacement with scale build up

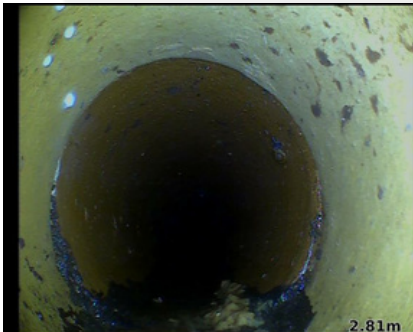
Observation [7]:
Joint displacement with scale build up

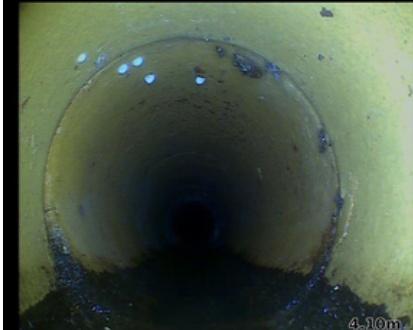
Observation [8]:
Joint displacement and cracking at 3 o'clock

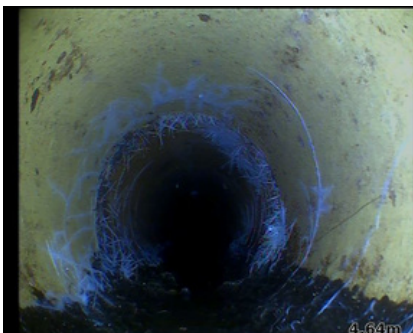
Observation [9]:
Crack at 3 o'clock

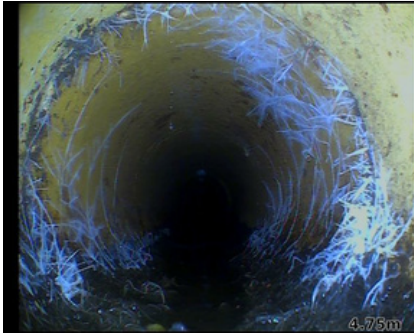
Observation [10]:
Root ingress

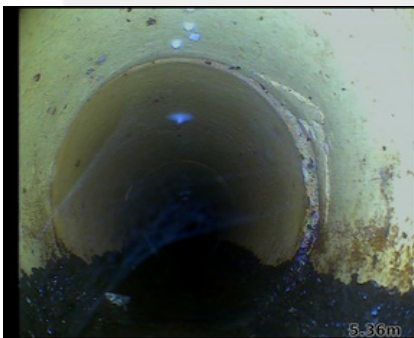
Observation [11]:
joint displacement and cracking at 3 o'clock

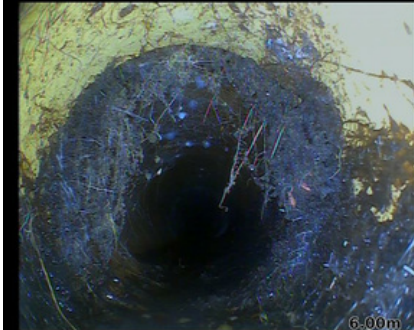
Observation [12]:
Root ingress

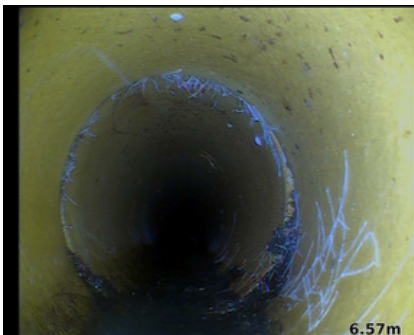
Observation [13]:
Joint displacement with root ingress

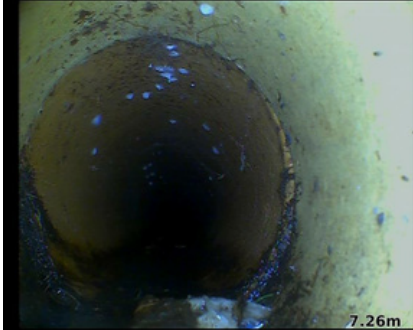
Observation [14]:
Joint displacement

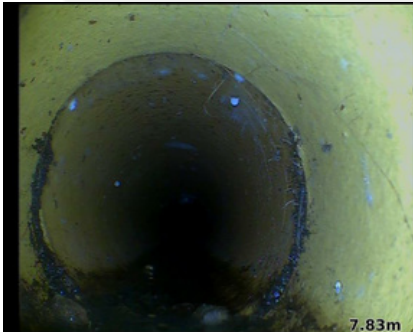
Observation [15]:
Joint displacement with root ingress

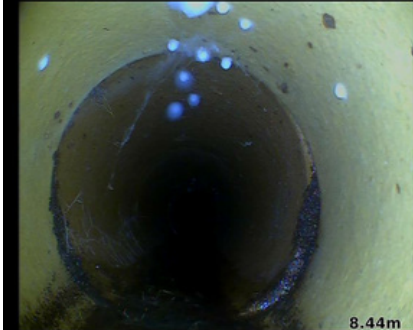
Observation [16]:
Joint displacement with root ingress

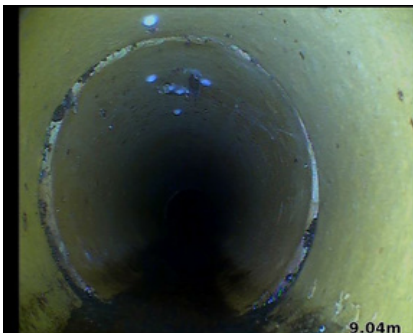
Observation [17]:
Joint displacement

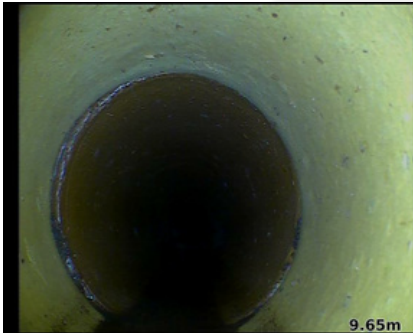
Observation [18]:
Joint displacement

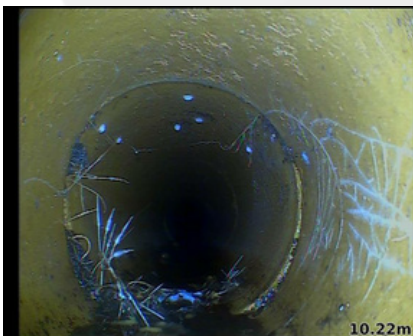
Observation [19]:
Root ingress

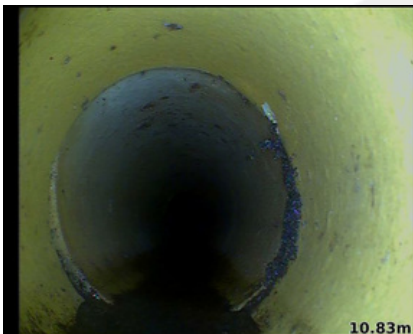
Observation [20]:
Joint displacement and root ingress

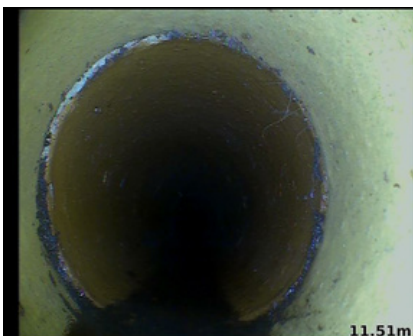
Observation [21]:
Joint displacement

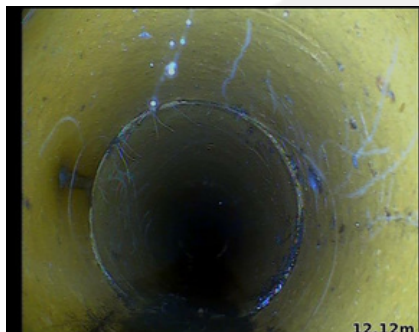
Observation [22]:
Joint displacement and cracking

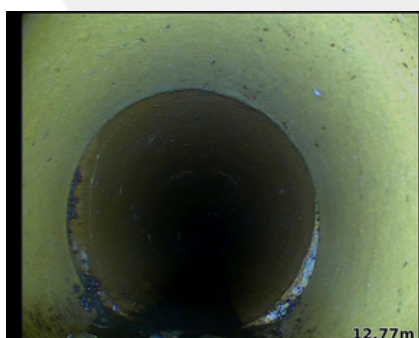
Observation [23]:
Joint displacement and cracking

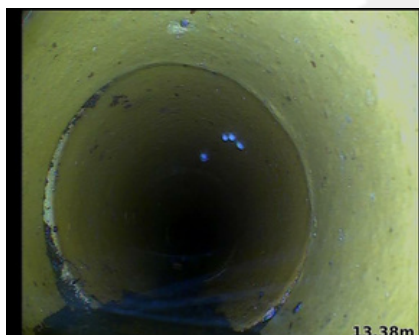
Observation [24]:
Joint displacement

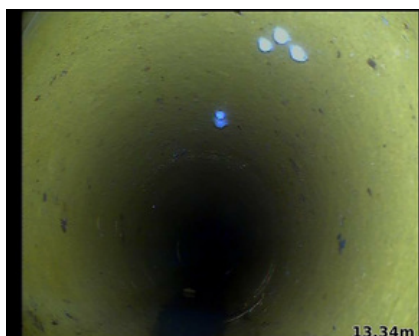
Observation [25]:
Cracking at 5 o'clock

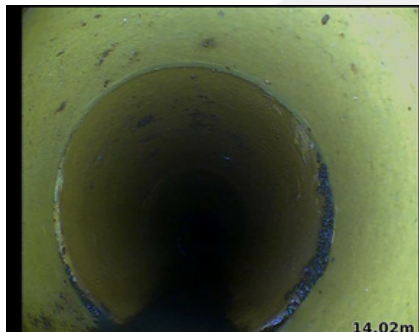
Observation [26]:
Joint displacement and root ingress

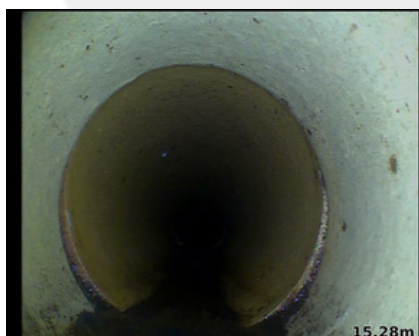
Observation [27]:
Joint displacement

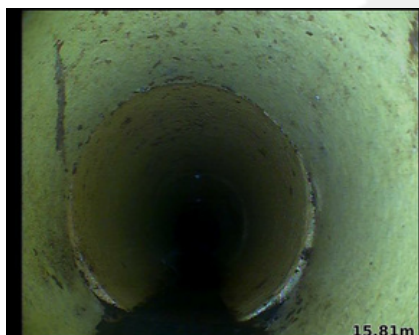
Observation [28]:
Joint displacement

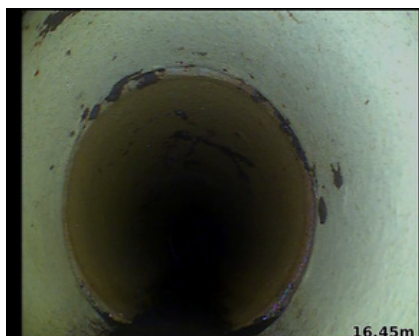
Observation [29]:
Joint displacement

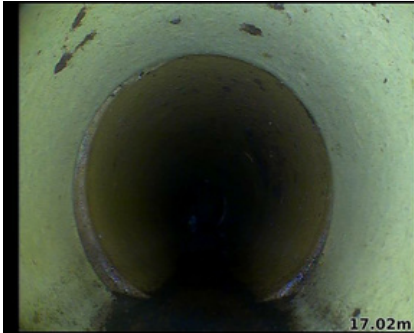
Observation [30]:
Joint displacement

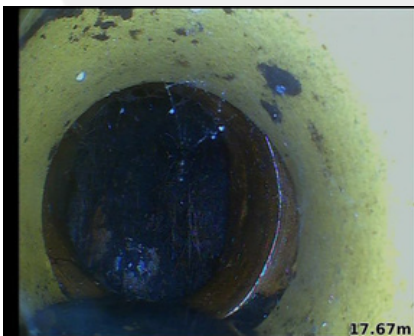
Observation [31]:
Joint displacement

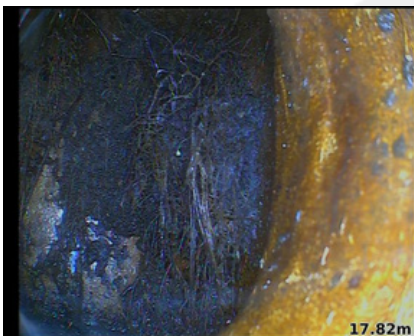
Observation [32]:
Buchan trap with root ingress
