LEVEL 2 HOME SURVEY

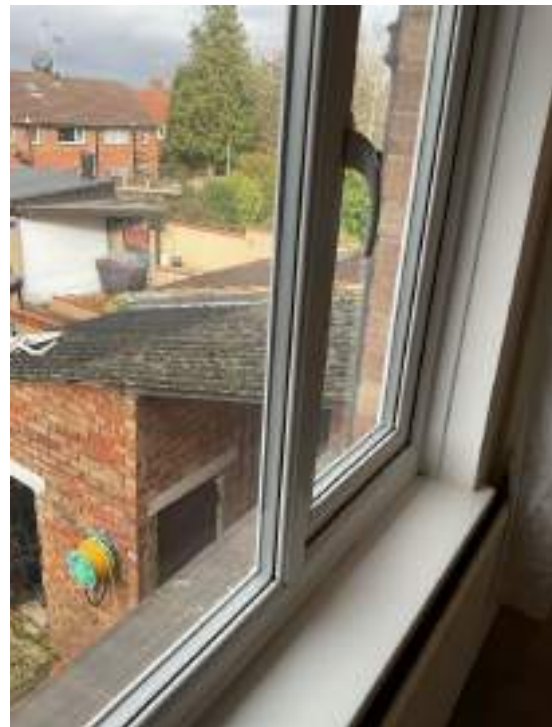
No installation date stamp on Windows

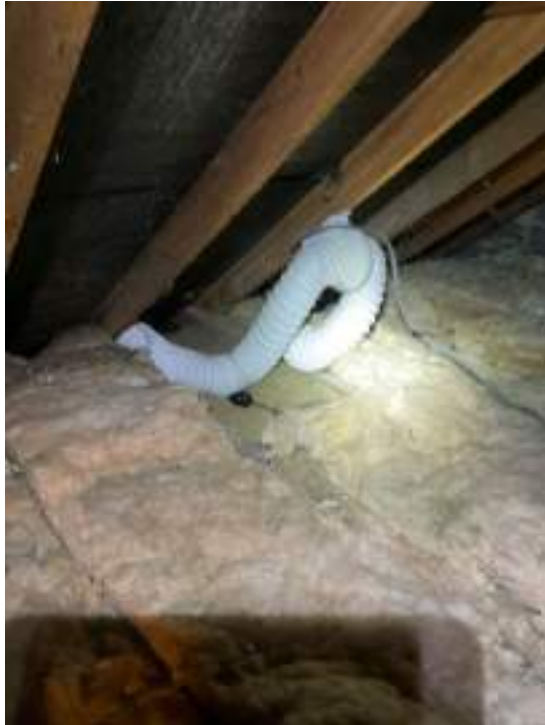
Tangled bathroom ducting

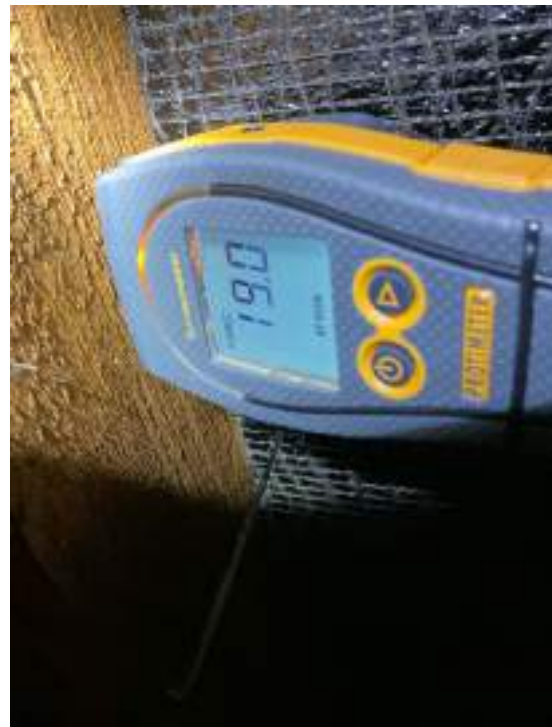
Damp readings ok

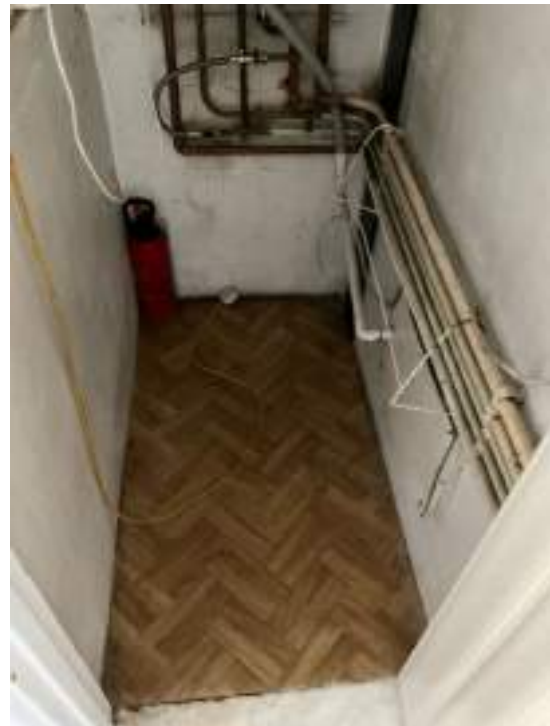
Damp readings in this area only

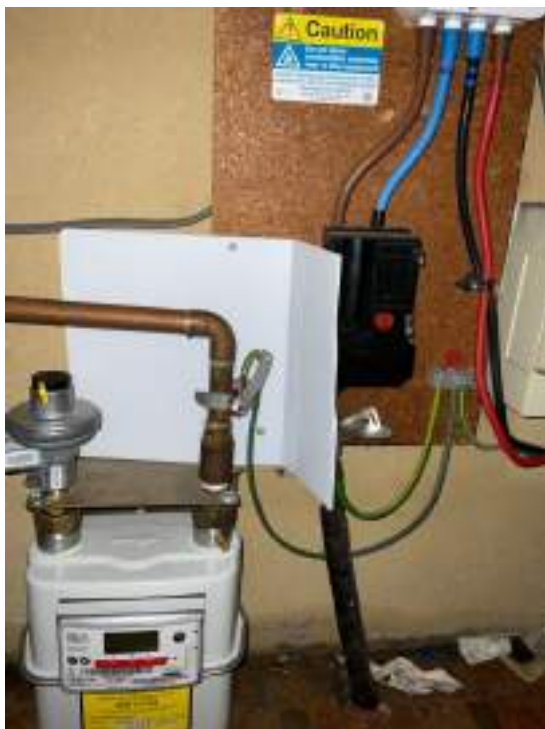
non conductive barrier

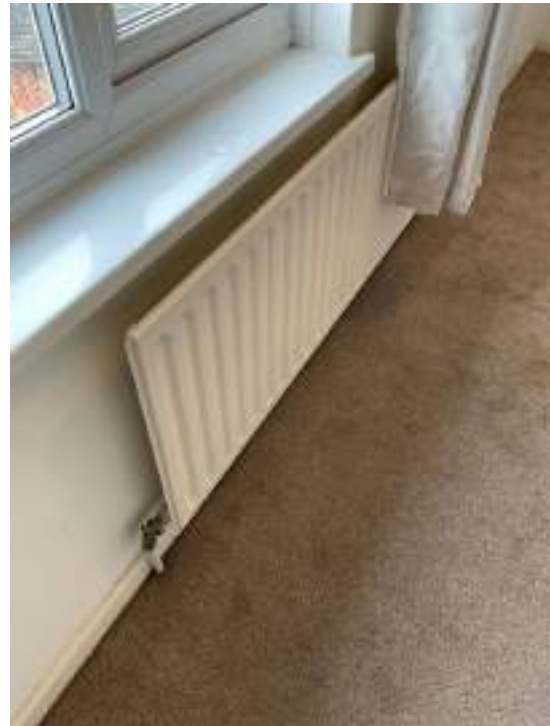
Single panel radiator

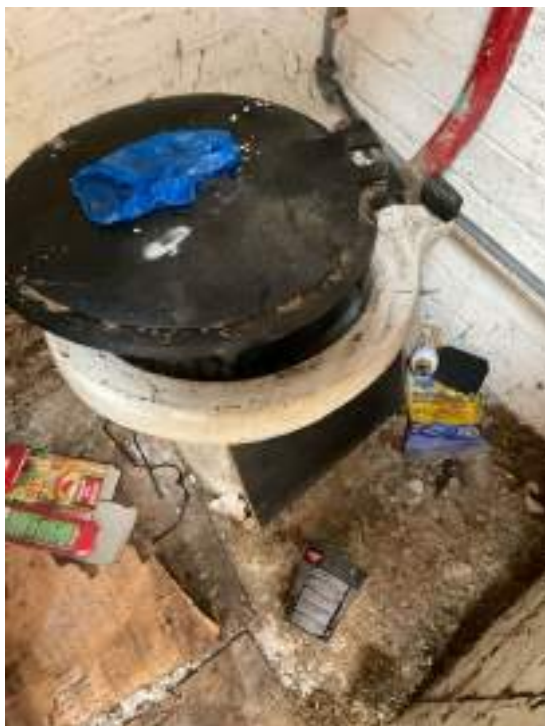
Parts of the stores are made out of material that may contain asbestos. These appear to be in satisfactory condition at present and should present no health risk if undisturbed. However, they should not be cut or worked in any way and specialist advice must be sought prior to being removed as this will prove costly.

Possible asbestos toilet seat cover redundant

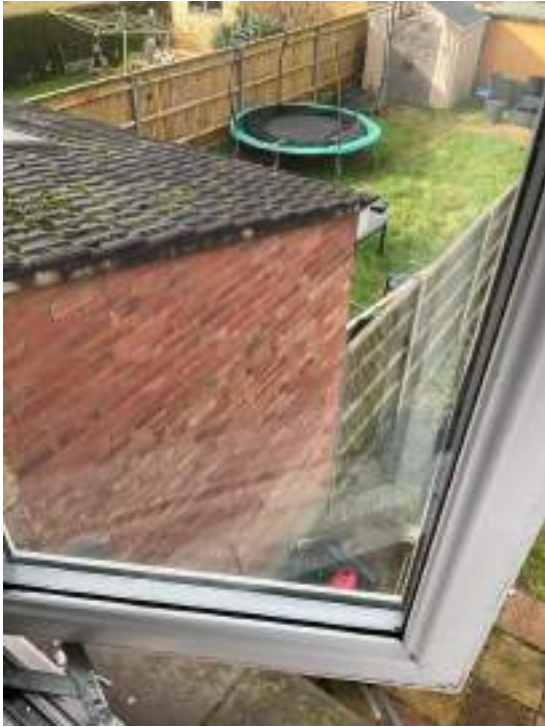
Party wall walks have been carried out to neighbouring properties on each side, solicitor should ascertain whether any party wall agreements have been put in place.

party wall agreement in place check required

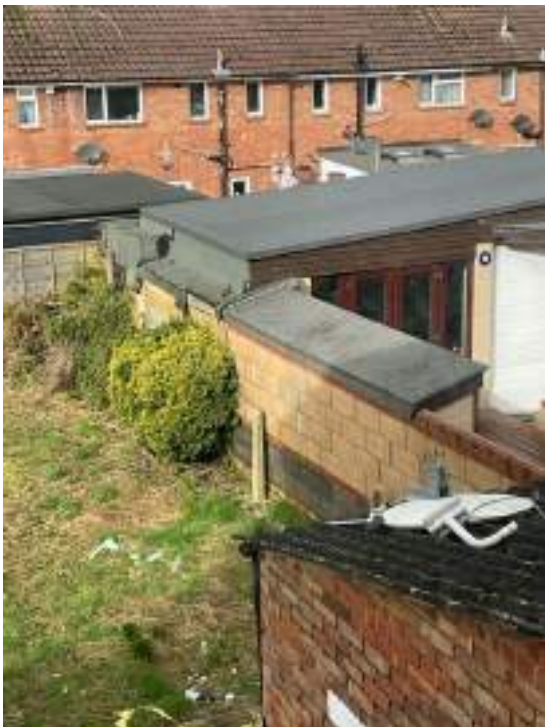
Party wall agreement in place check required
