LEVEL 3 BUILDING SURVEY

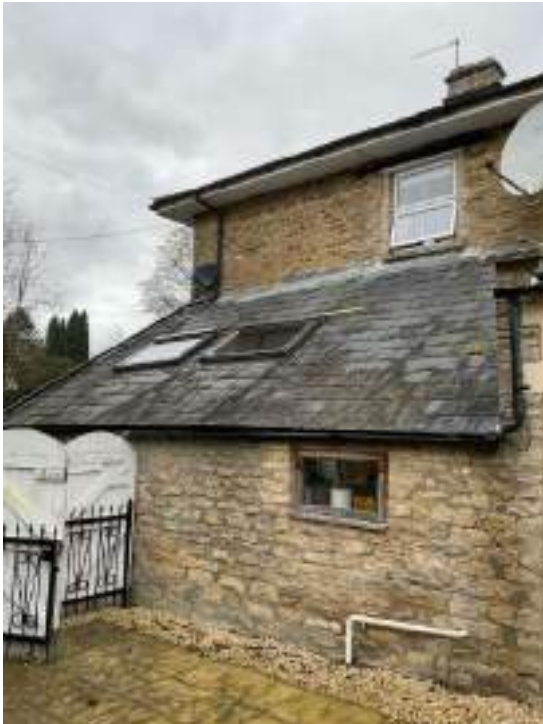
The covering was generally functional but we noted slipped slates. Repair and maintenance works

Utility roof covering

We recommend that a certified roofing specialist is consulted to verify the above and below findings, and inspect any other possible defects in the roof and/or any chimney flue/stack in the immediate term, which are to be remedied as and when required, prior to exchange, purchase and occupation. Open joints in the tiling, notably at the ridge tiling, or slipped, cracked, or missing tiles may be present and should be remedied in the immediate term.

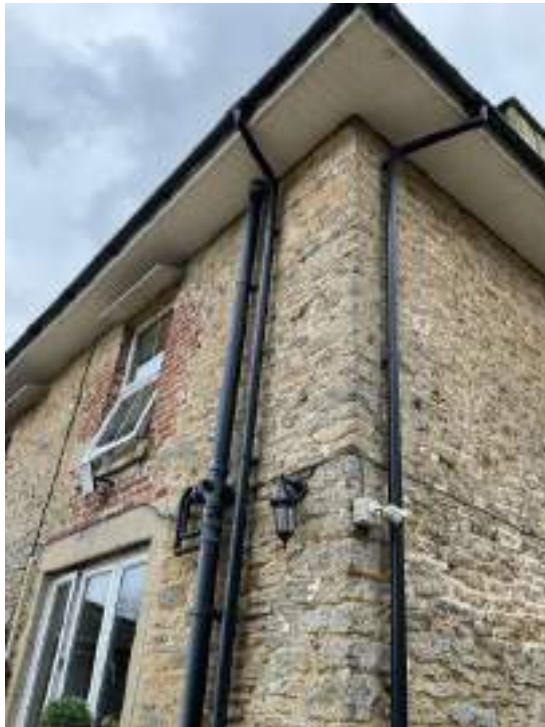
Downpipes to building

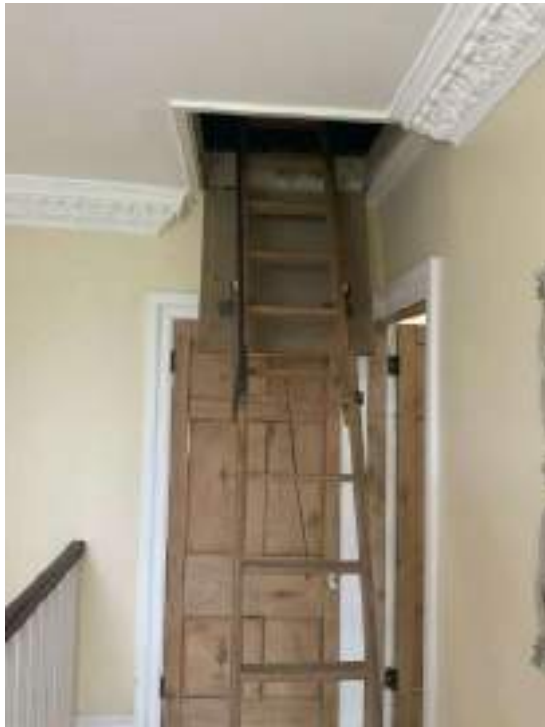
Loft access via hall hatch

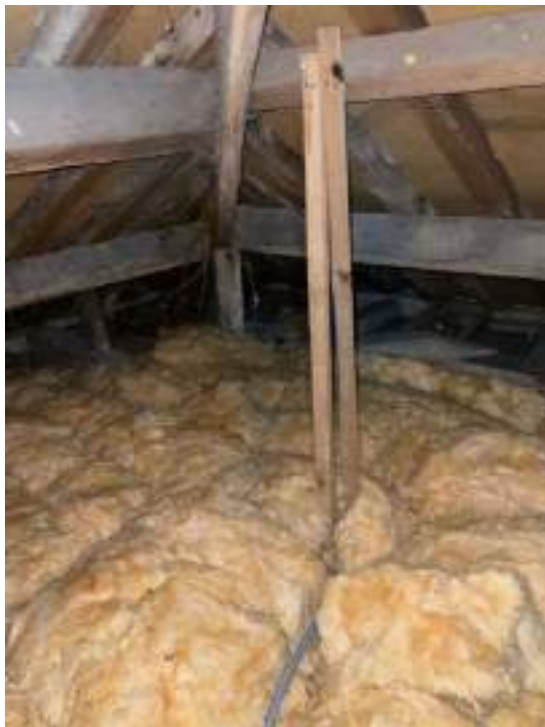
Limitations within the roof void

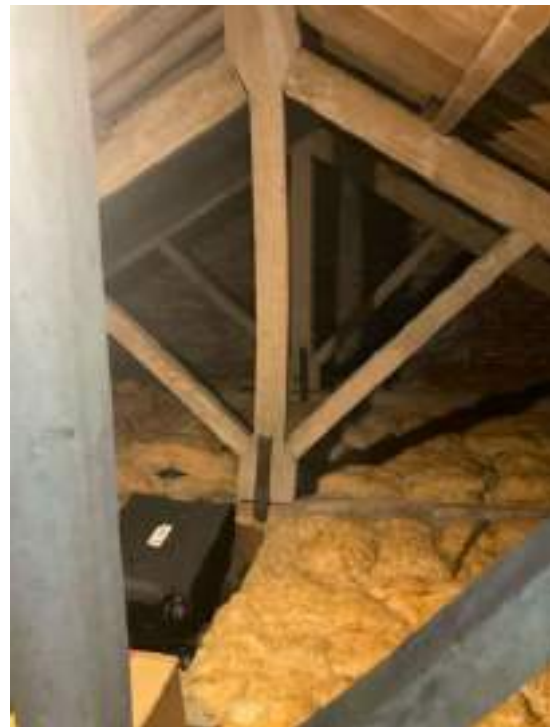
Roof with limited access to all parts

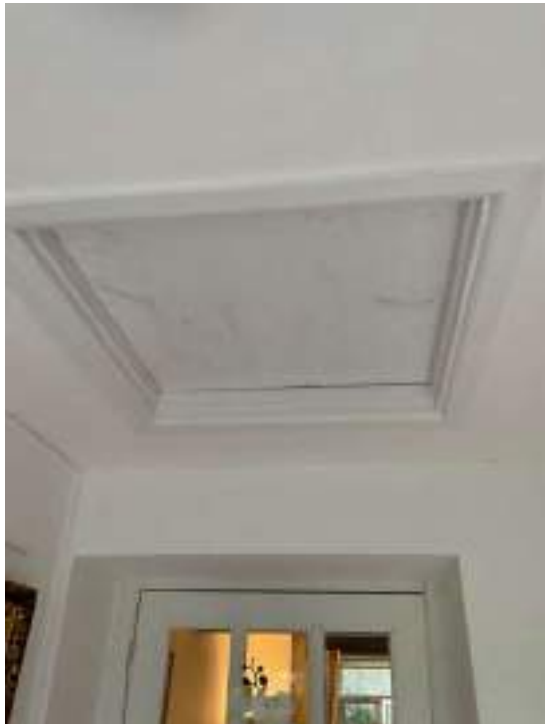
2nd hatch to ground floor roof void with cables and pipe works

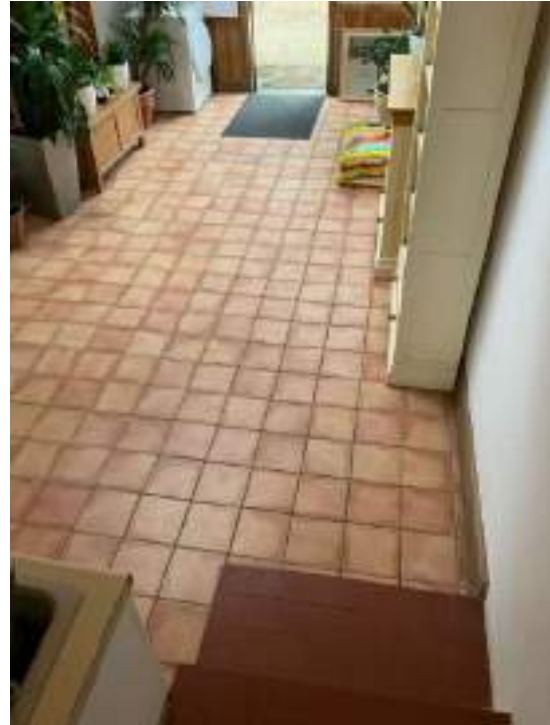
Utility floor and ground floor solid with no damp proof membrane

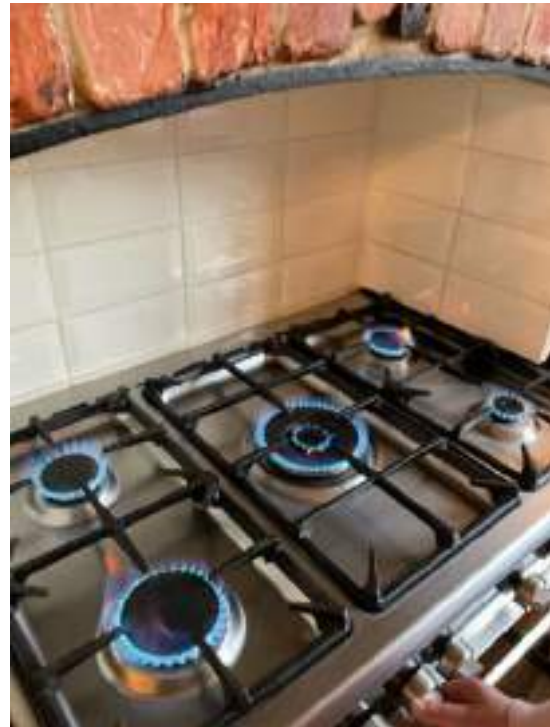
Oven and hobs tested use gas tanks

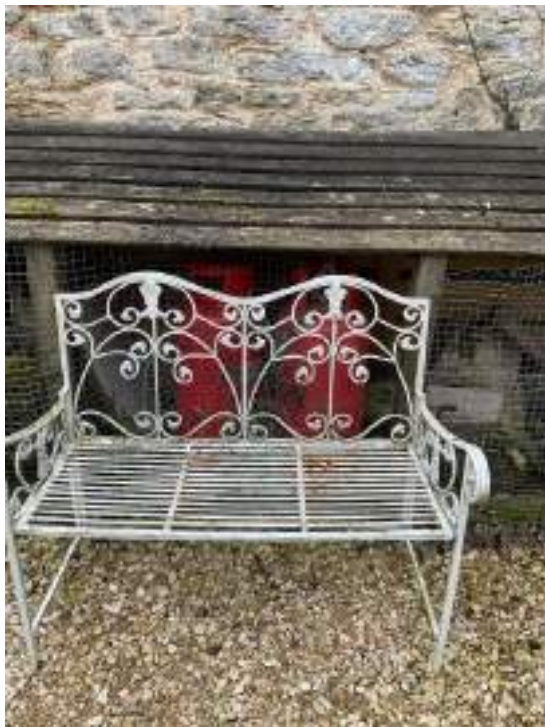
Gas tanks which supply the cooker behind the bench

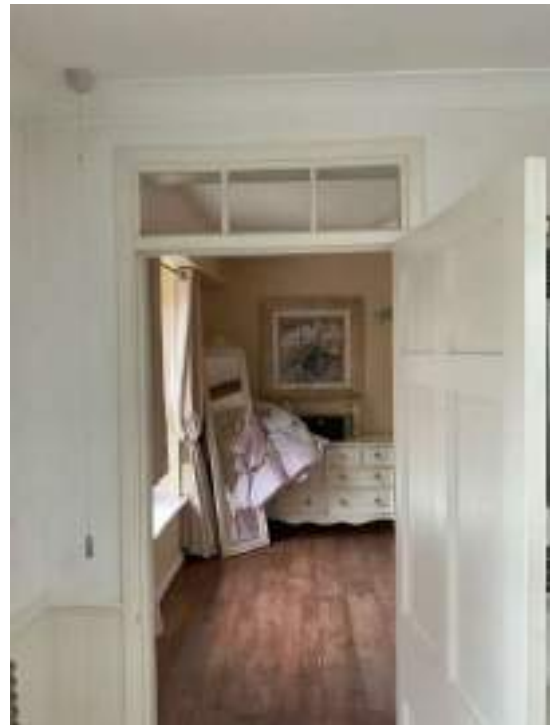
Not safe glazing

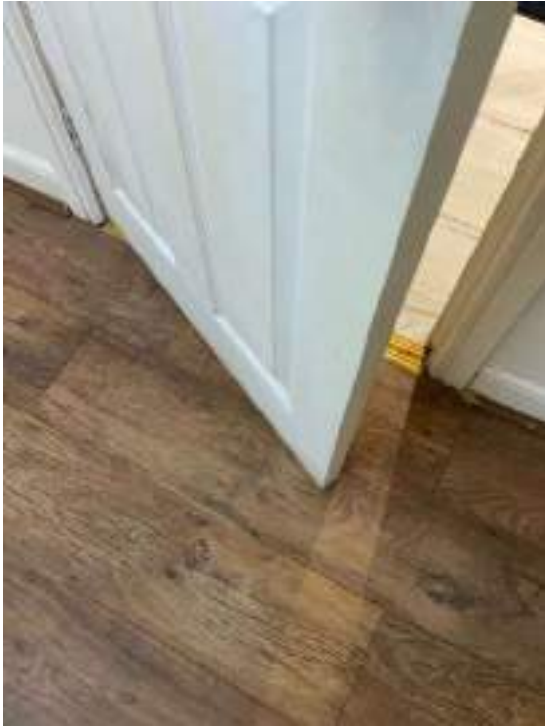
Door catches on the floor

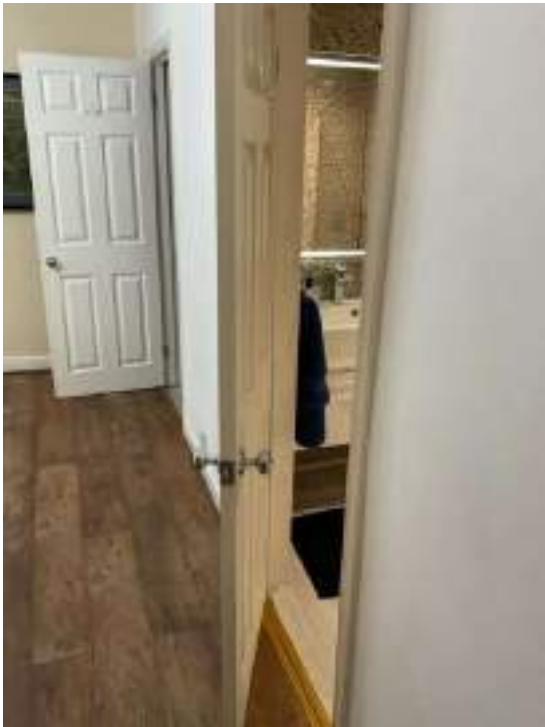
Due to timber expansion the bathroom door rubs on the floor

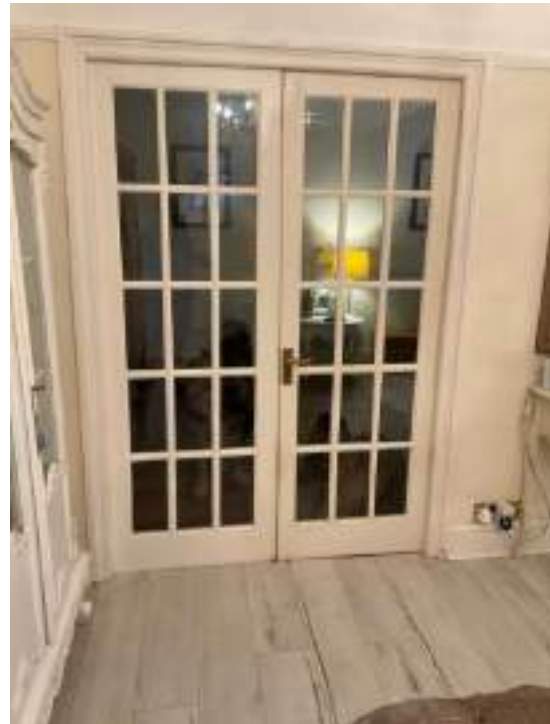
Stiff doors and no safety glazing stamps to internal doors

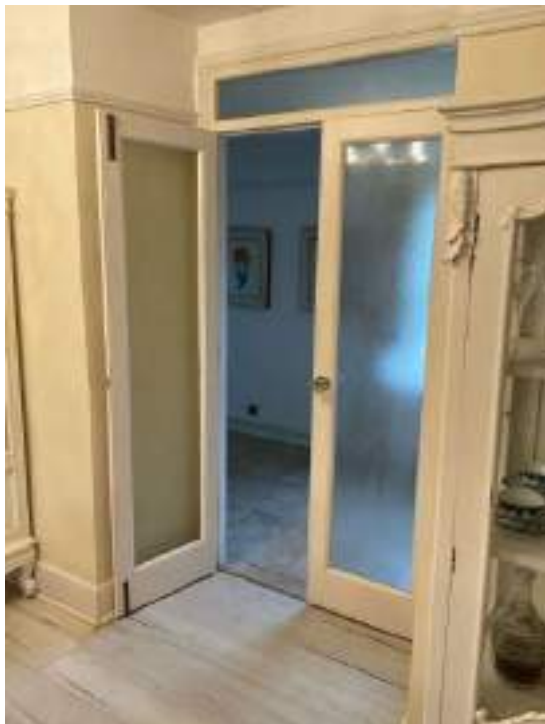
Stiff doors and no safety glazing stamps to internal doors

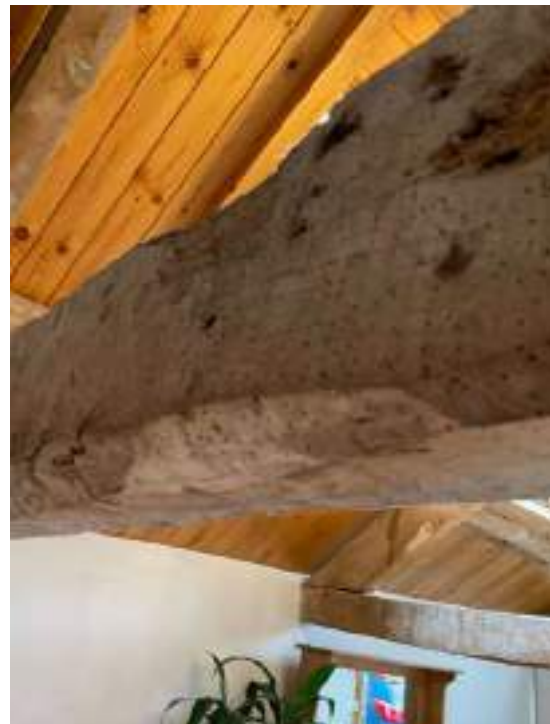
old wood boring infestation - not active

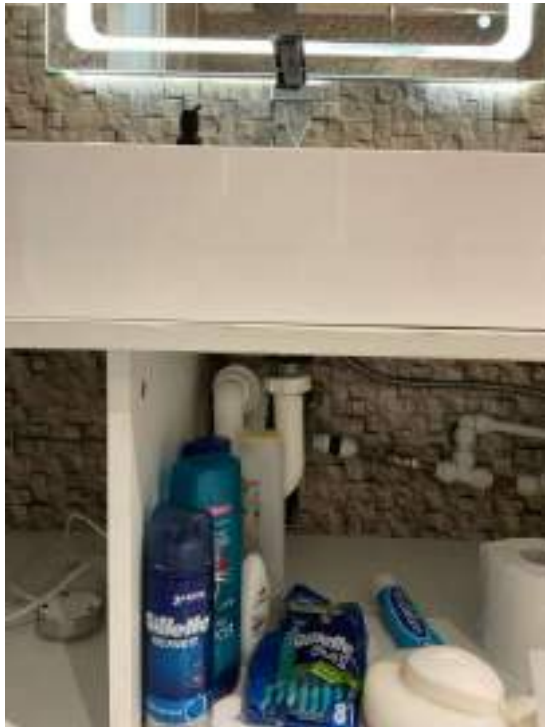
No leaks noted

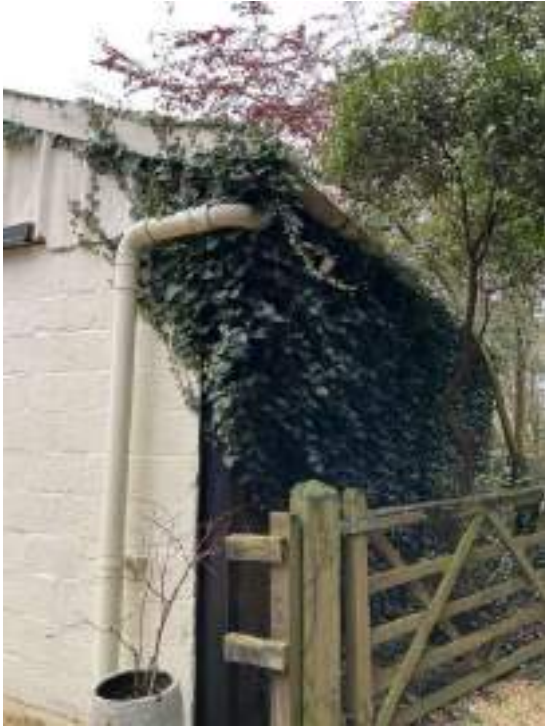
Vegetation growing out of the gutter front and rear

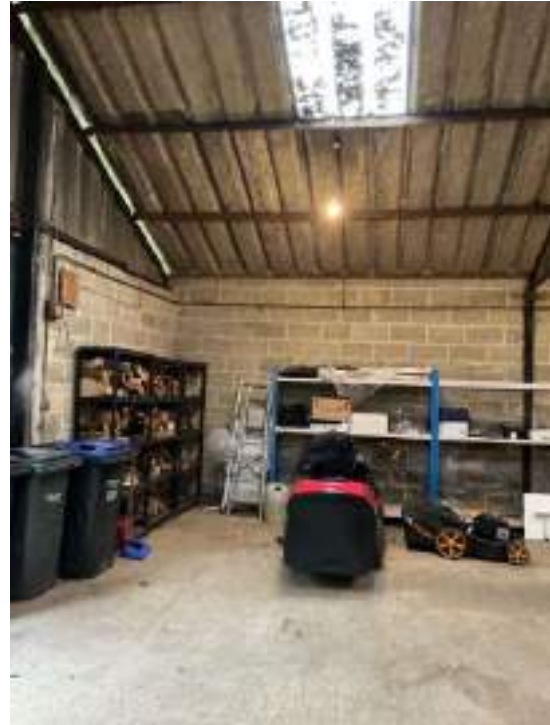
Possible asbestos containing material

In a property of this age asbestos-based components are likely to have been used, some of which are hidden within the structure. This should be borne in mind when undertaking any works to the property. Should asbestos-based materials be found then they may need to be dealt with by specialist contractors and this could prove expensive. Further advice is available from the Health & Safety Executive - <https://www.gov.uk/search?q=asbestos>.
