Project Report

Section Video:
mh1_

Start: Mh1
Pipe line Size

End:
Stack pipe

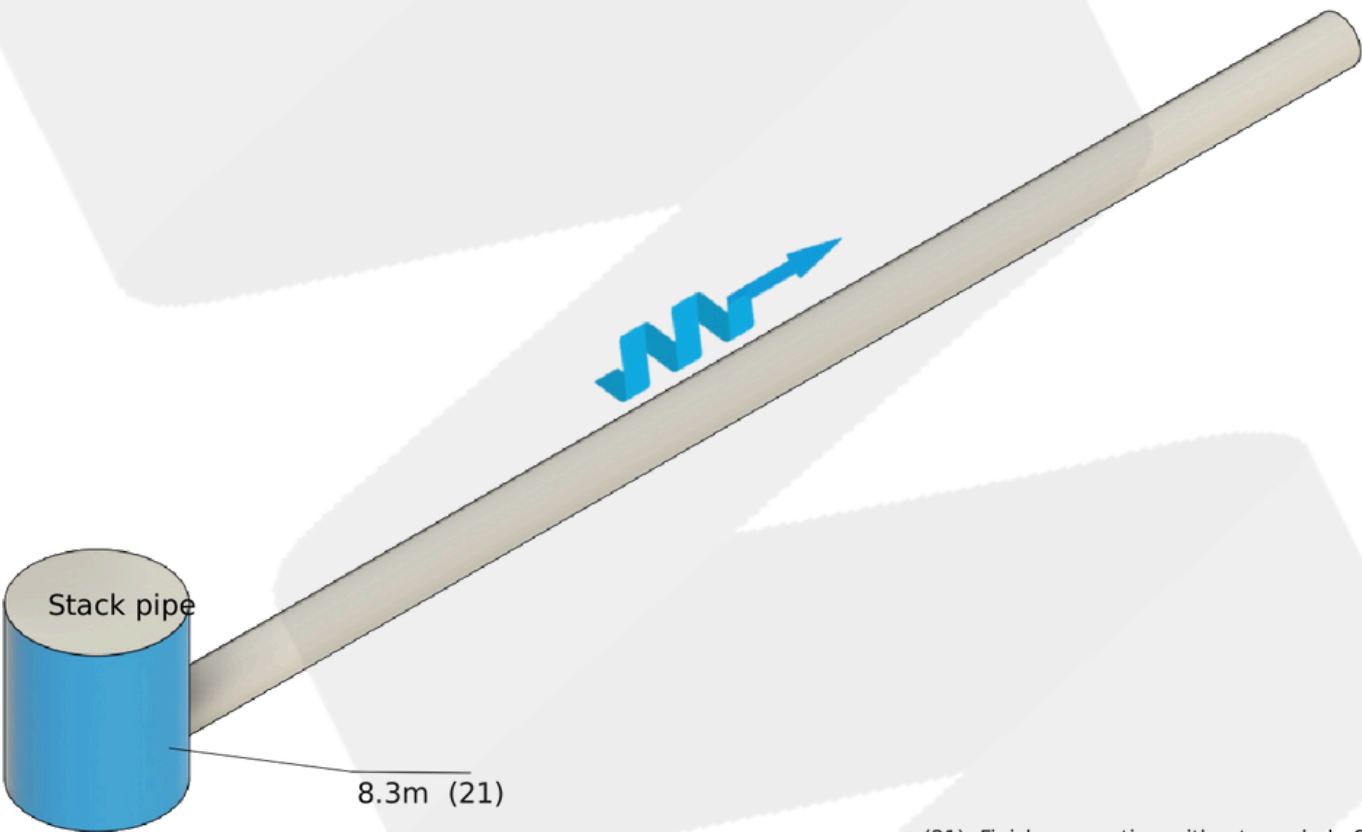
(21) Finish connection without manhole Stack pipe

A significant joint displacement was found at the base of the soil vent pipe. This defect would require a local excavation to expose the pipe and carry out a repair, as trenchless methods (such as lining) cannot reposition displaced joints effectively. Left-Hand Lateral Connection (towards gully) Severe cracking and damage were noted at a lateral 'Y' connection. This section requires excavation and replacement of the damaged junction with a new, structurally sound connection. Buchan Trap (rear garden) The trap is heavily infiltrated by roots, and there is no long-term solution other than excavation and removal. Replacing the trap with a straight through pipe section would prevent roots from regrowing. The extent of root ingress and any trapped debris at the base of the trap cannot be fully confirmed until excavation is carried out. Rear Garden Gullies Both gullies appear to be blocked with silt and debris. These require manual clearance and high pressure water jetting to remove obstructions from the gully pots and u-bends. Once cleaned, further inspection should be undertaken to check for any hidden structural damage. Front Downpipes (at the property frontage) Two gutter downpipes currently discharge directly at the base of the property, with no proper drainage system in place. This can cause water to accumulate against the building, leading to damp issues and, in the worst cases, long-term foundation damage. It is strongly recommended to redirect these into a suitable drainage system or a newly installed soakaway.
