LEVEL 2 HOME SURVEY

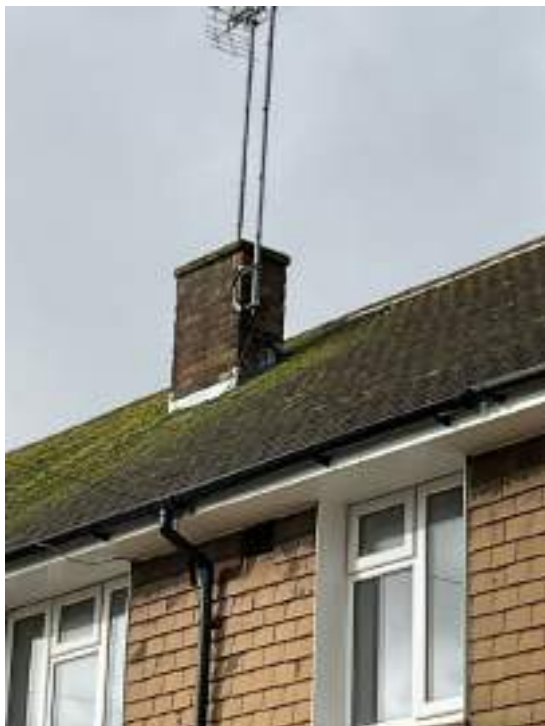
Side

The stack appears to be in generally satisfactory condition, well-formed and with no significant defects noted. Normal maintenance will be required to ensure the stack is watertight.

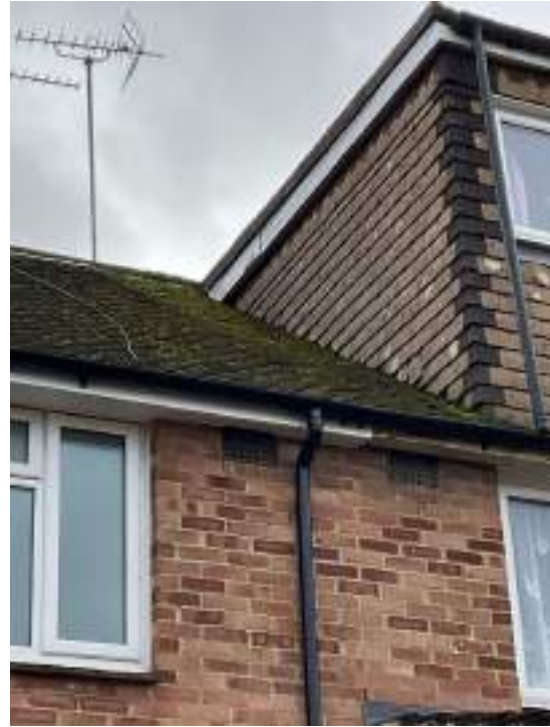
The covering was generally functional but we noted poor ventilation provision and moss growth. Repair and maintenance works should be carried out to ensure that the roof remains weathertight and does not leak.

Moss growth.

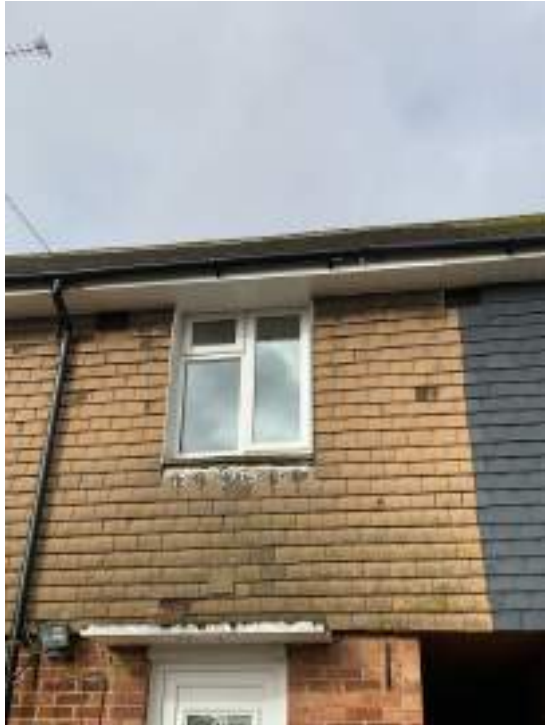
Stop end Front elevation

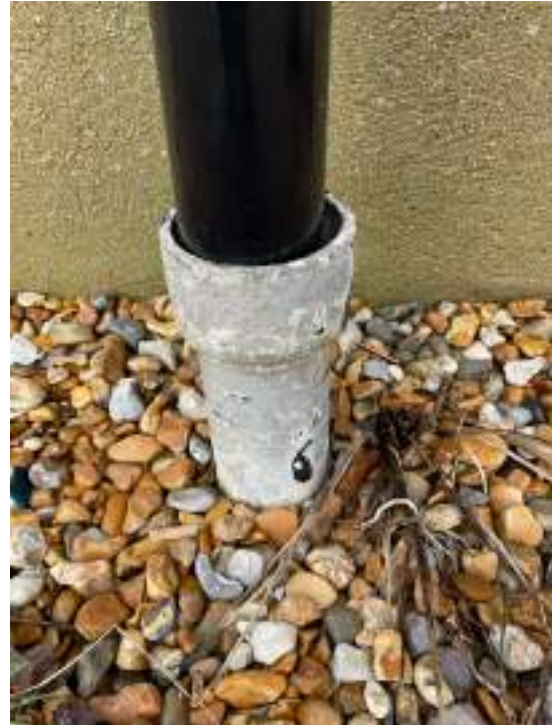
Possible asbestos

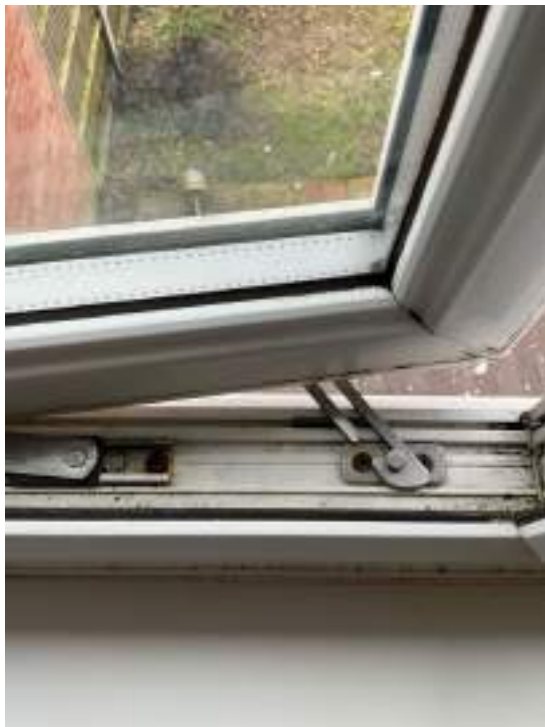
Safety catches

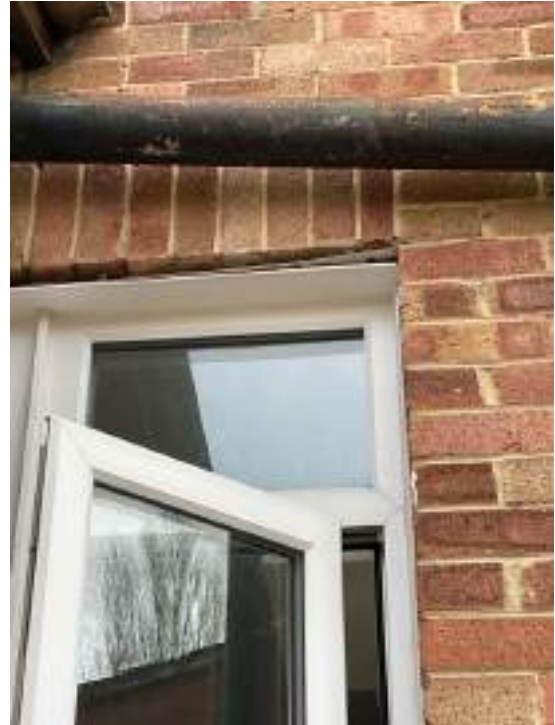
Instalation. please check Fensa

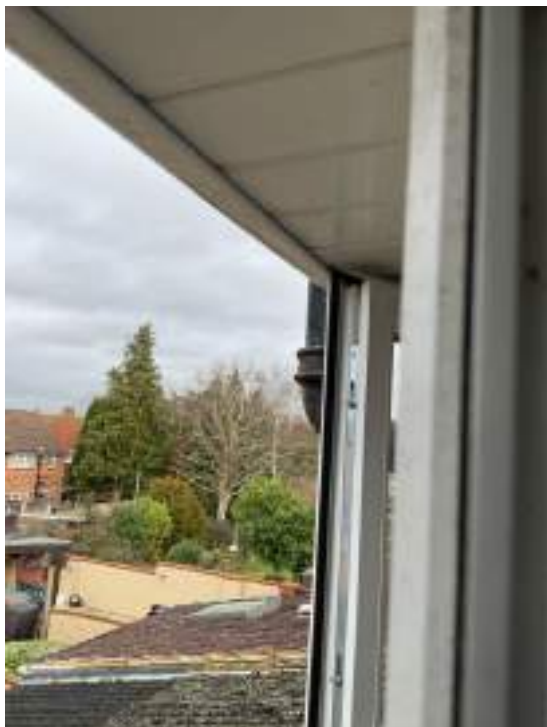
Not vented

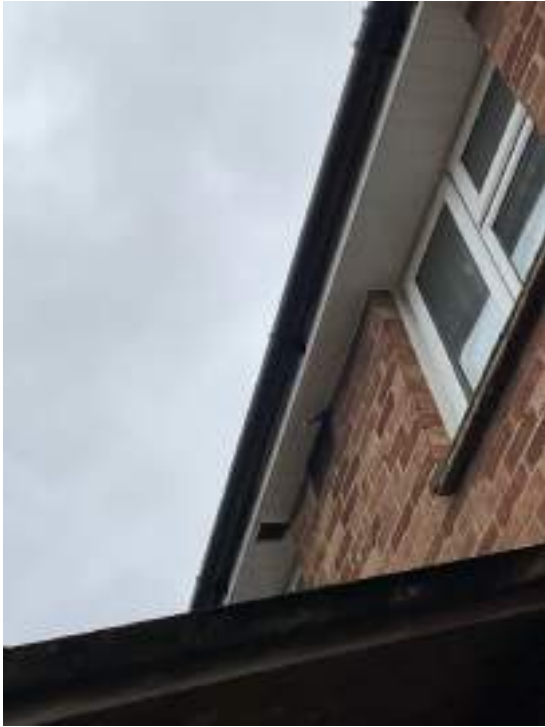
Not vented

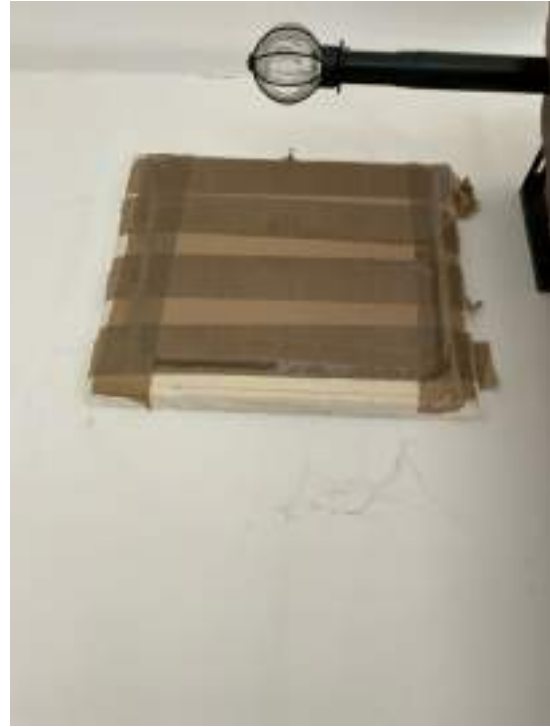
Walls have vents

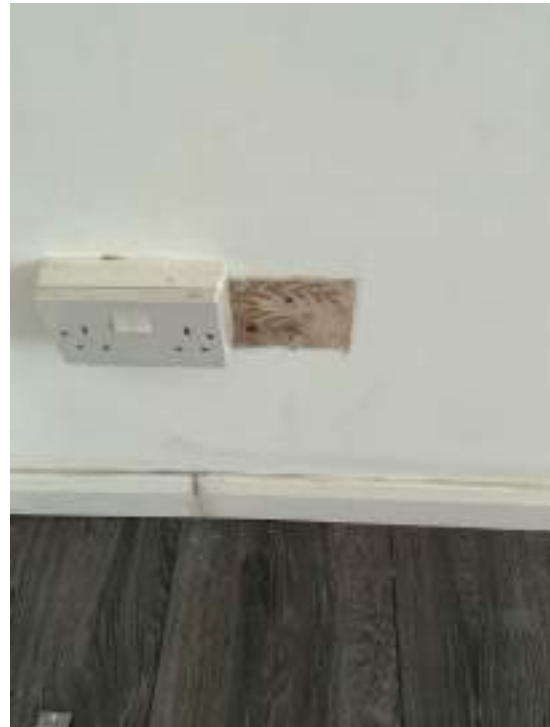
Redecorating required

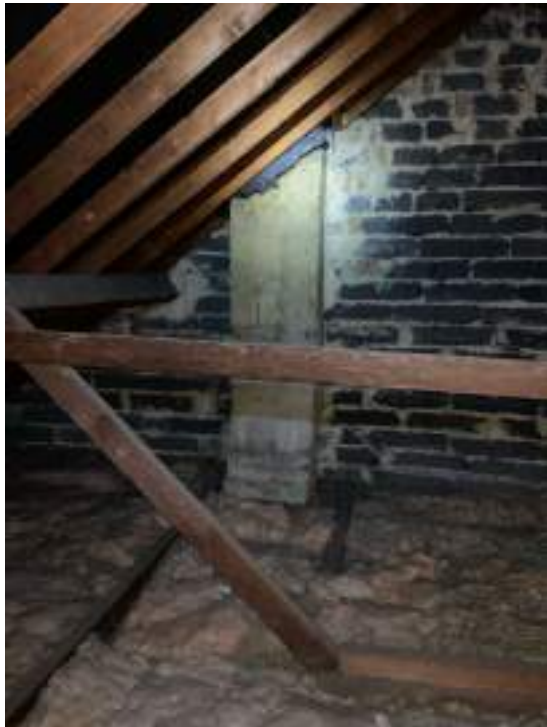
Breast in loft

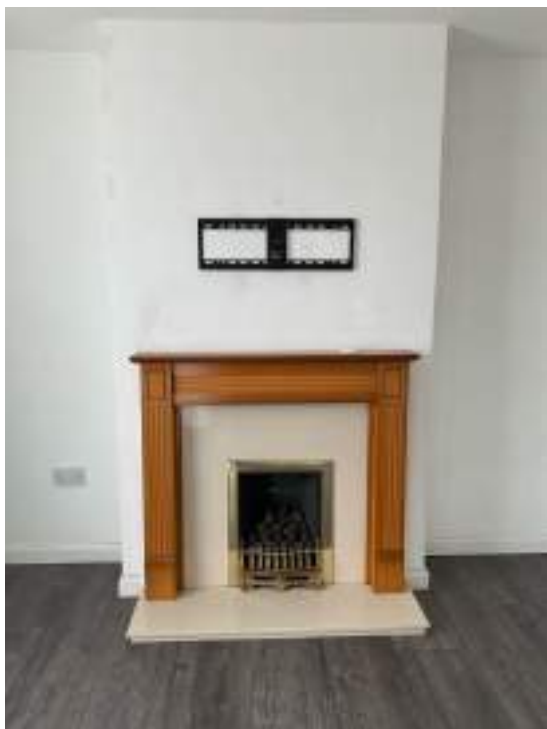
Gas fire to lounge

It is not possible to indicate the condition of flues or the presence of flue liners. As a precautionary measure, we would advise that any gas appliances are serviced and examined by a Gas Safe registered contractor to ensure both the safe and efficient operation of the appliances and the flues. The contractor should also confirm that adequate ventilation has been provided to this appliance.

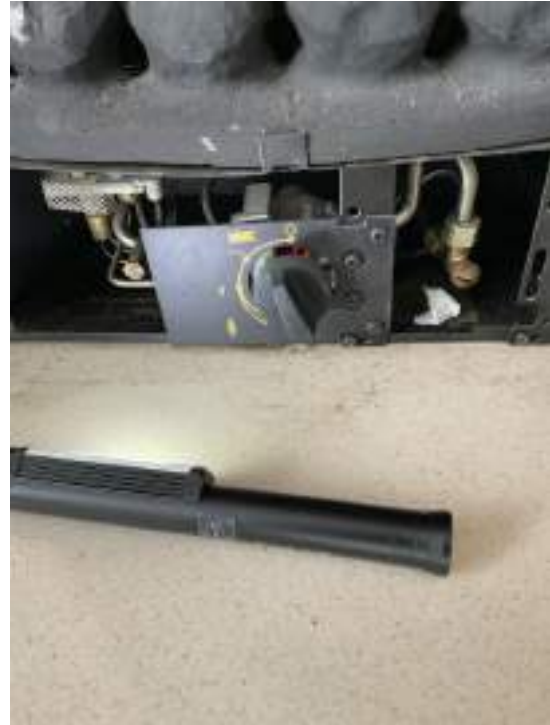
Gas Safe registered contractor to check

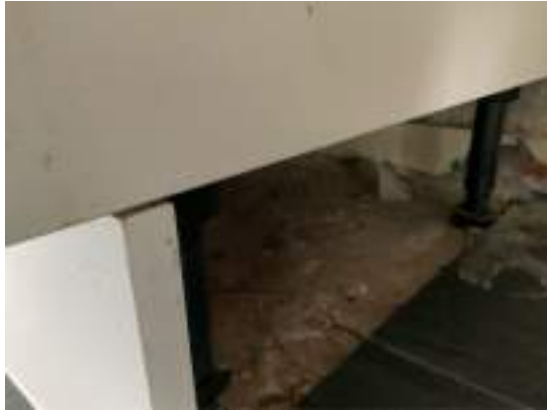
No stop cock seen

Internal stopcock, not found.

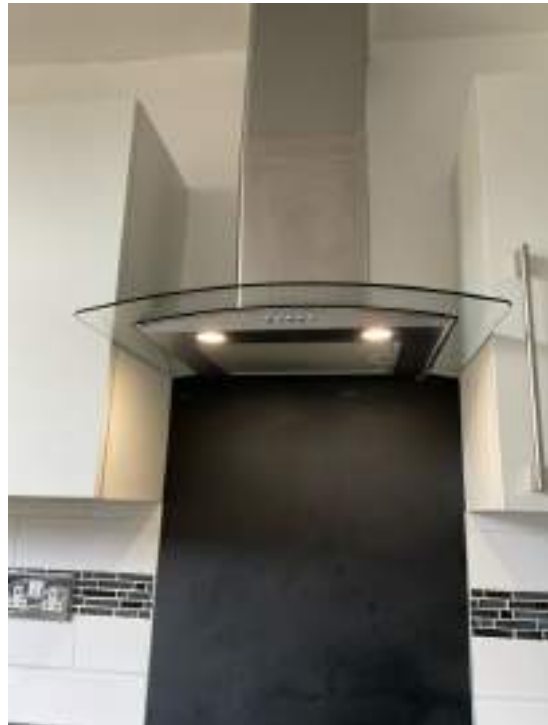
Carbon filter not advised

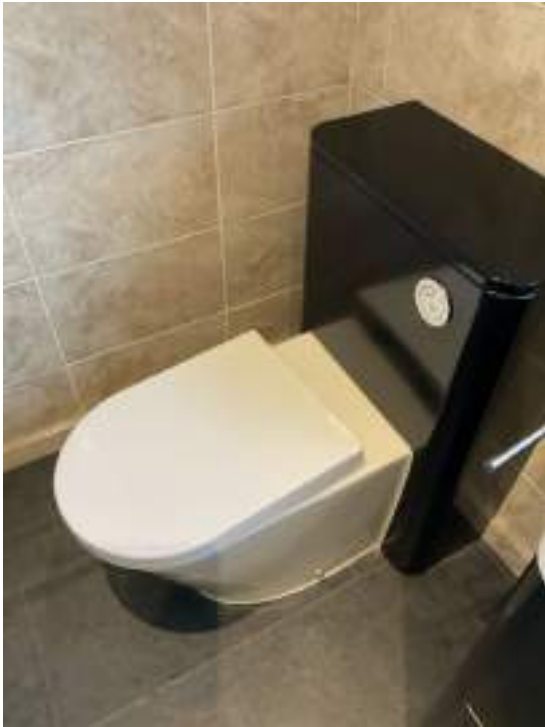
The sanitary fittings are functional but we noted defects such as a loose WC seat and repairs and improvements are required.

loos seat

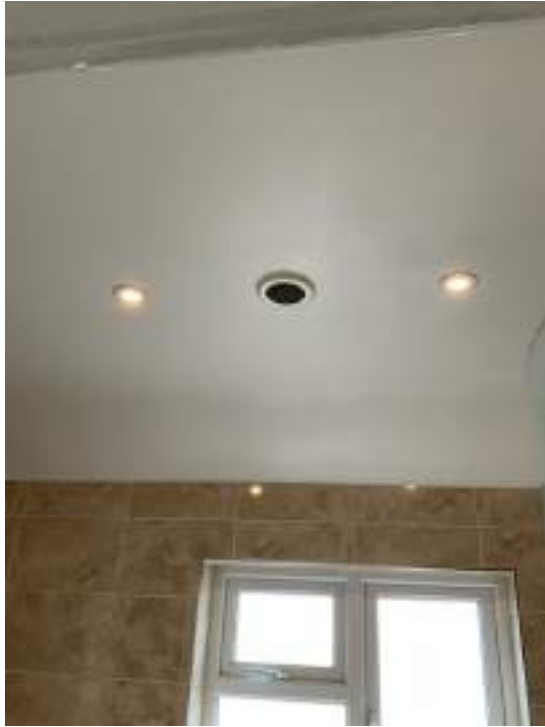
mev system should extract system

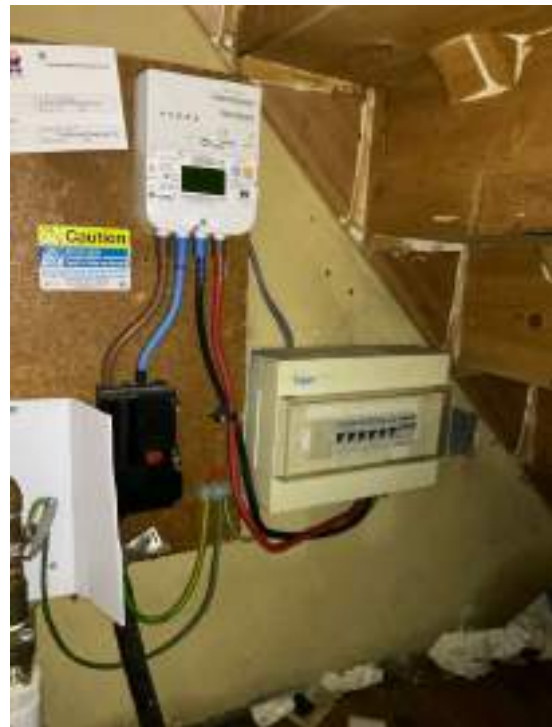
Dated counsumer unit request an EICR

Our visual inspection revealed that the installation appeared to be functional. However, in view of the guidance given above relating to the change of occupancy, we recommend that the installation should now be checked by an appropriate specialist registered with either the NICEIC or a similar approved body prior to the exchange of contracts.

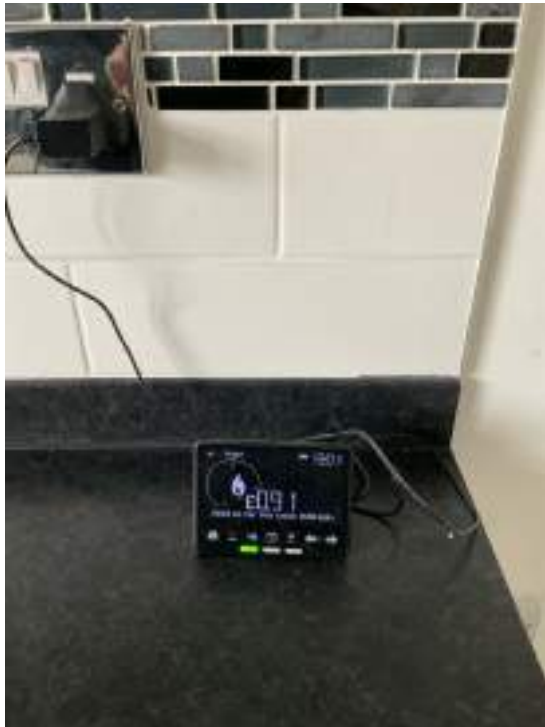
should be 150mm apart

In view of the guidance above and as a matter of safety, you should now arrange for the installation and all gas appliances to be inspected and tested by a Gas Safe engineer prior to the exchange of contracts.

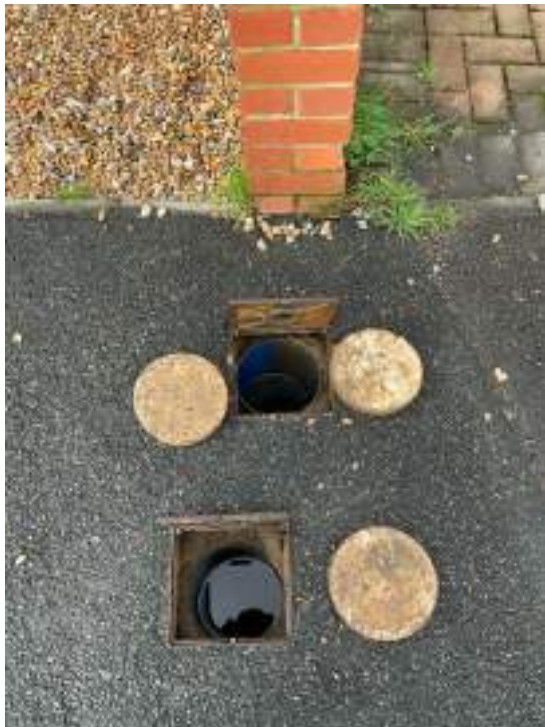
Upon inspection, the external water stopcock was found to be flooded. This may indicate a potential issue such as a leaking pipe, which could result in additional costs for the purchaser. It is recommended to address this matter promptly, considering the possibility of a leaked cover, seal or water ingress from below. It is advisable to involve the water company and seek legal advice for further investigation and resolution.

Seek advice from water company

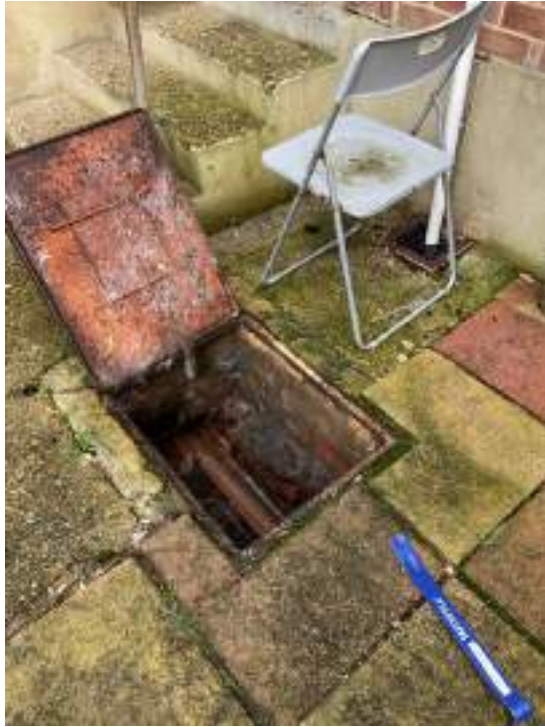
IC

Covers were raised where possible and, in these positions, the chambers were noted to be free from blockage or other obvious serious defects. Please note, however, that this limited form of examination does not constitute a formal drains test and should not be construed as such. Should you wish to be appraised as to the condition of the whole system, a full drainage inspection should be commissioned prior to purchase.

Inspection chambers and gullies should be maintained to a good standard. Therefore, they should be checked and jet-washed/cleaned annually. Periodic repairs may be required from time to time.

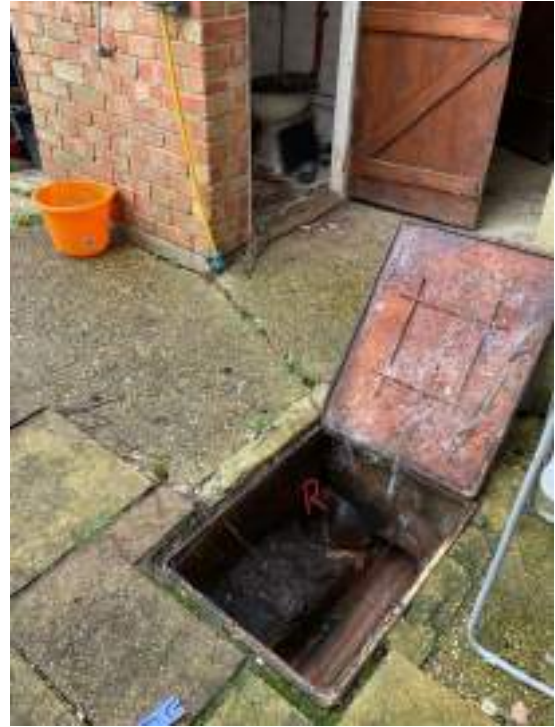
Redundant line

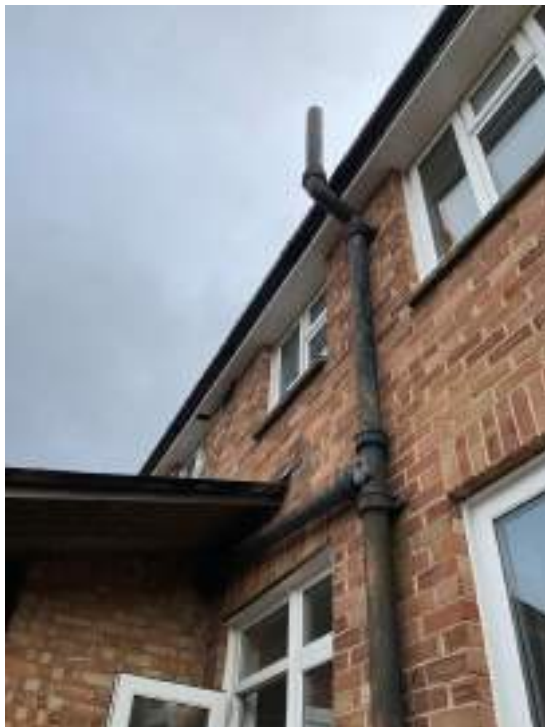
No bird guard

A bird guard should be fitted to the summit of the stack to prevent blockages and associated defects.

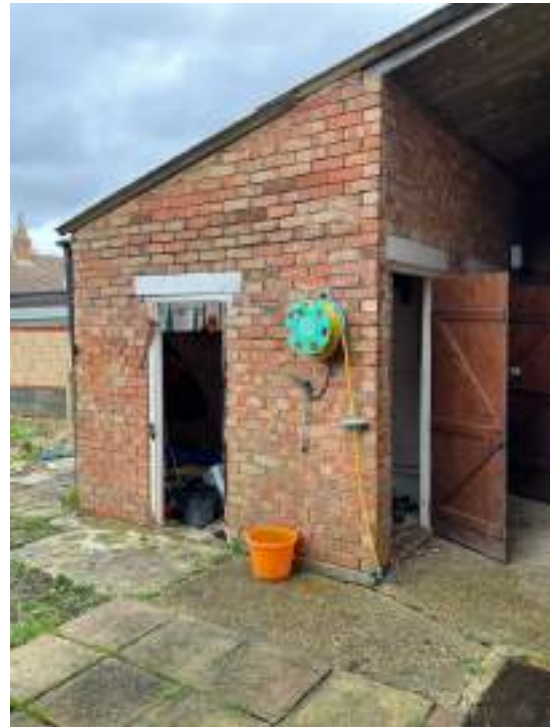
Outbuilding/stores

The stores are in a poor condition, built to a basic standard and have been poorly maintained. They are of no economic value and demolition and reconstruction, if required, is the most realistic option. You should obtain estimates, prior to the exchange of contracts.

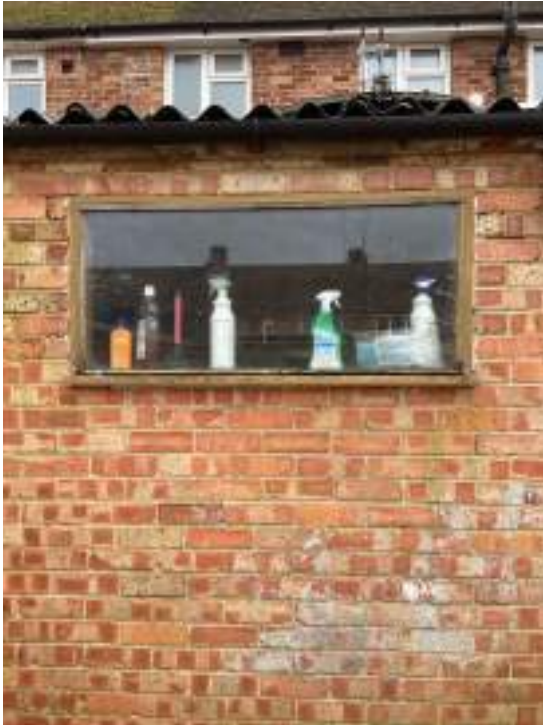
Non-safety glazing

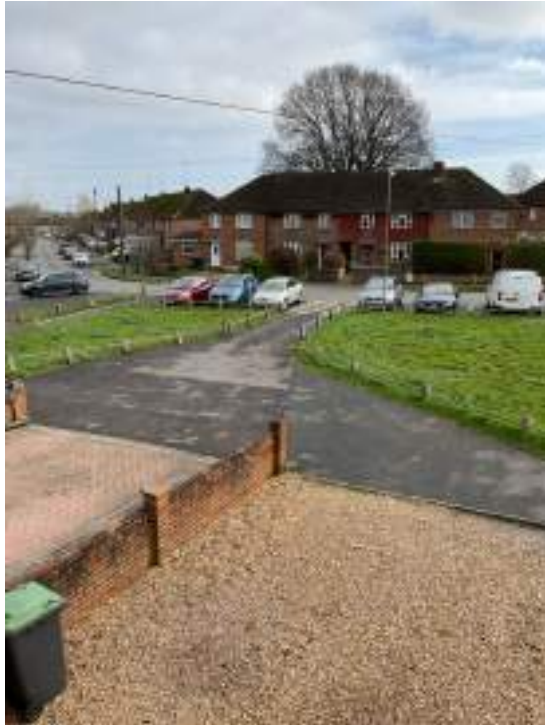
Check if Road is adopted

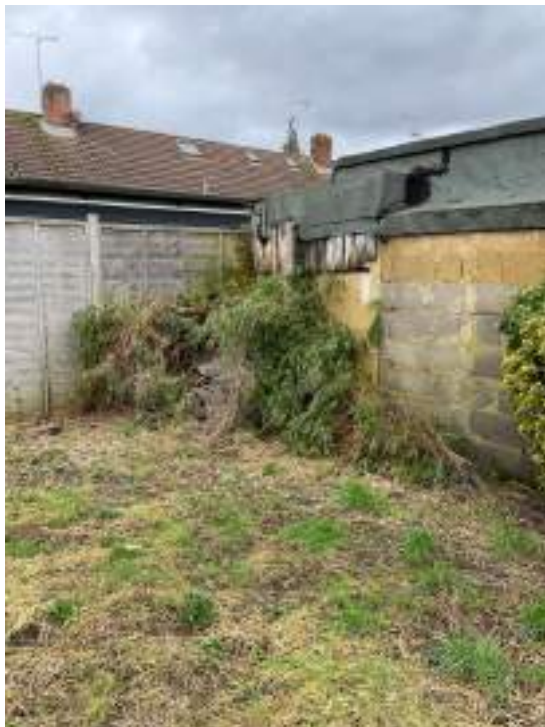
Bamboo was noted to the rear garden, this left unattended can cause significant damage and the bamboo should now be fully eradicated from the garden.

bamboo in garden
