LEVEL 3 BUILDING SURVEY

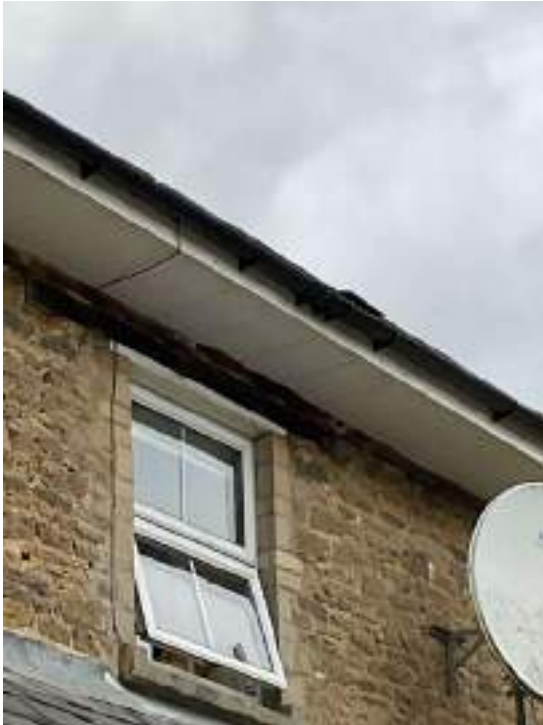
Soffits should be vented to increase air flow to loft void

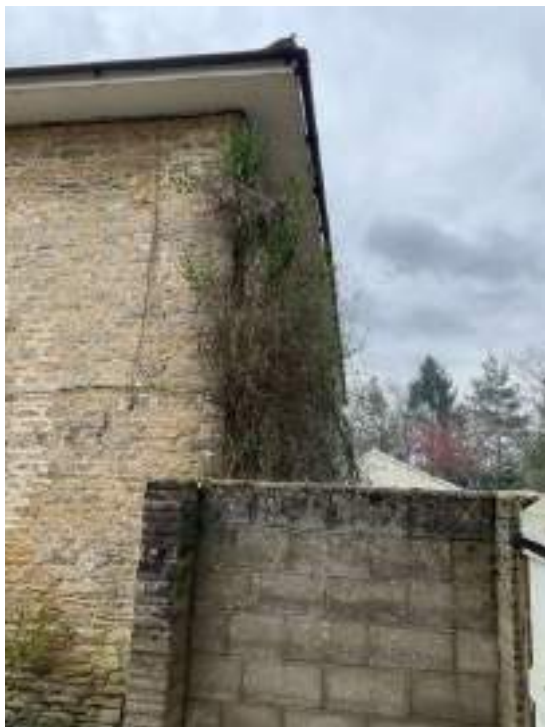
Vegetation should be removed

Vegetation should be removed from the walls as they soak in moisture and cause damage to the building

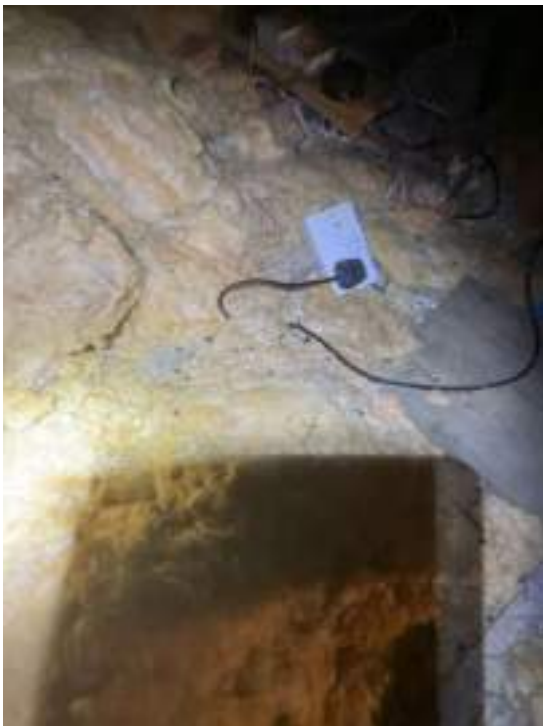
Where visible the electrical wiring is of a PVC-sheathed type. In places, it has been buried beneath loft insulation. This can cause overheating of the wires which could lead to fires. All covered cables must be re-positioned on top of the insulation.

Vermin droppings and electrics

You should ensure that your electrician checks the electrics within the loft area as part of the overall system inspection.

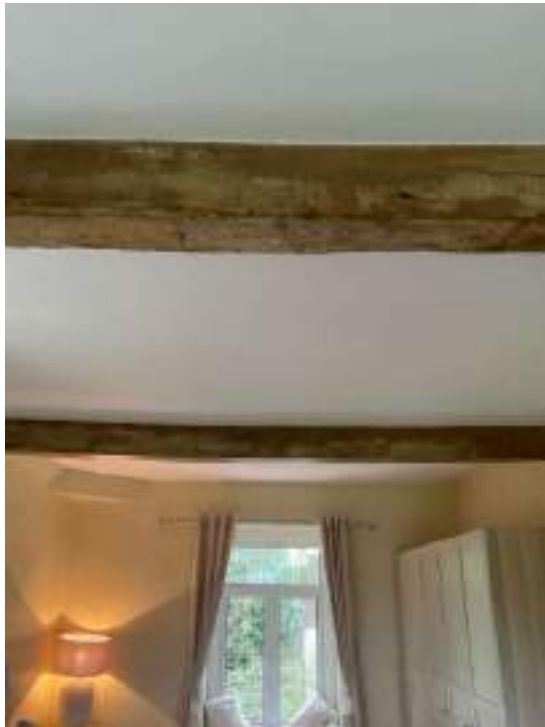
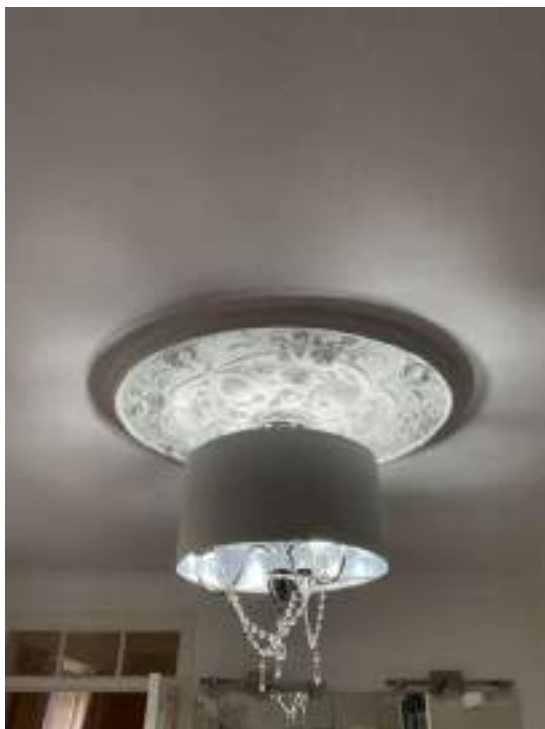
The ceilings are in a serviceable condition, however, localised areas of hairline shrinkage cracking were noted, which is a result of thermal changes in the building materials and is considered cosmetic in nature. These can be attended to during normal routine re-decoration periodically. These types of cracks are very common in a property of this age and type of construction and do not give cause for concern.

Ceilings

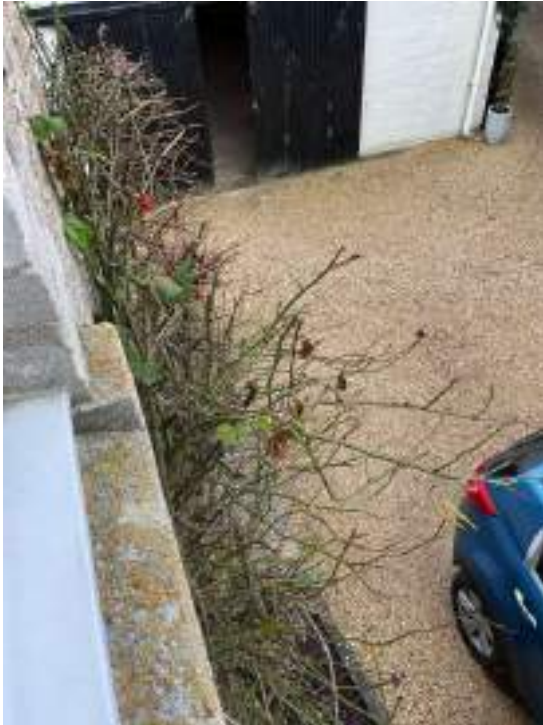
Possibly due to the vegetation growth, this should be removed

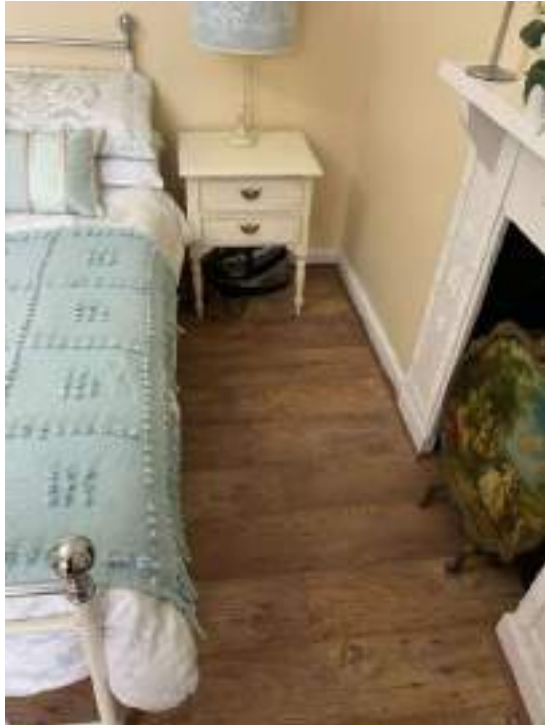
Slight spring and deflections to the first floor

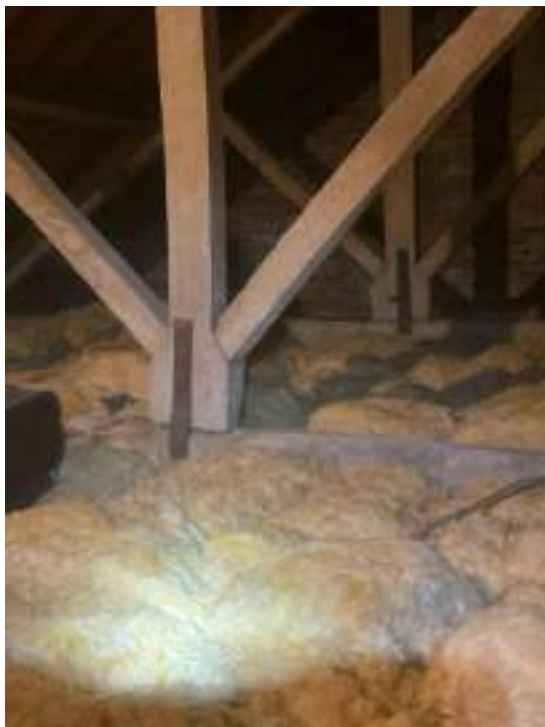
Unable to reach access to breast in loft

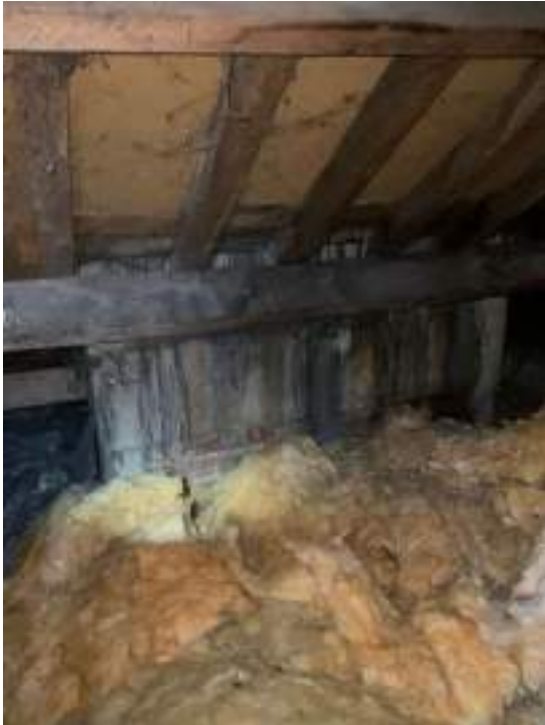
Kitchen breast condition appeared in order within the limited view

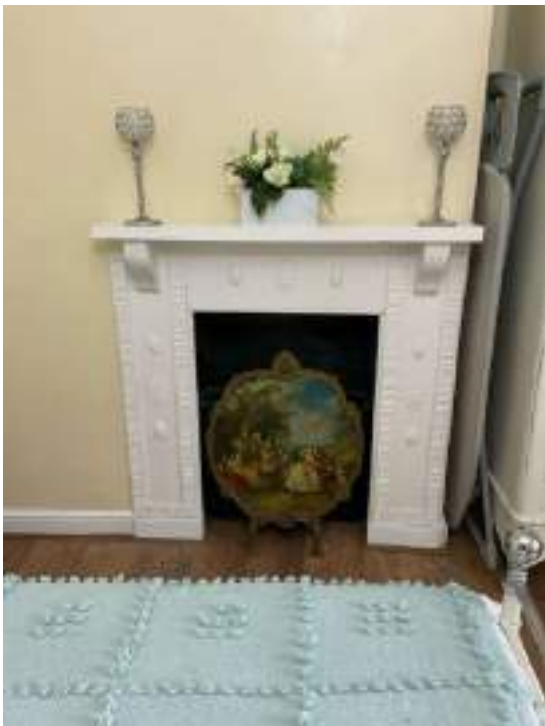
Bedroom 2 redundant

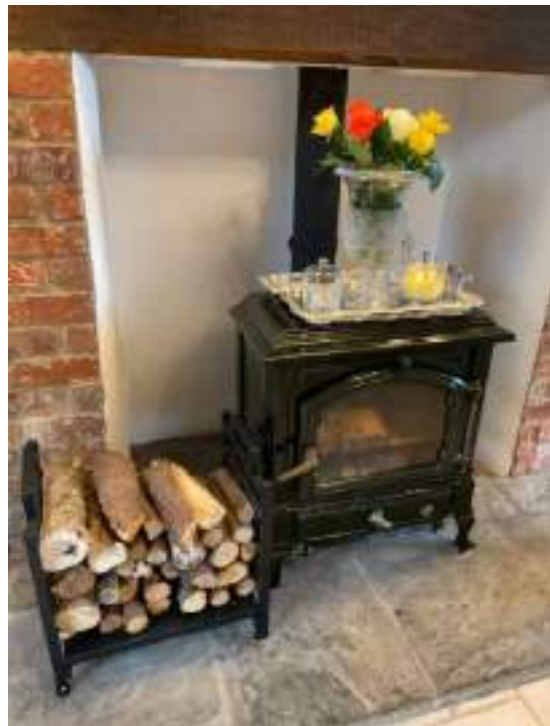
HETAS certificate required

These require having ventilation in the room where situated if the stove output is more than 4kw. For this, we therefore recommend a certified (HETAS) specialist is consulted.

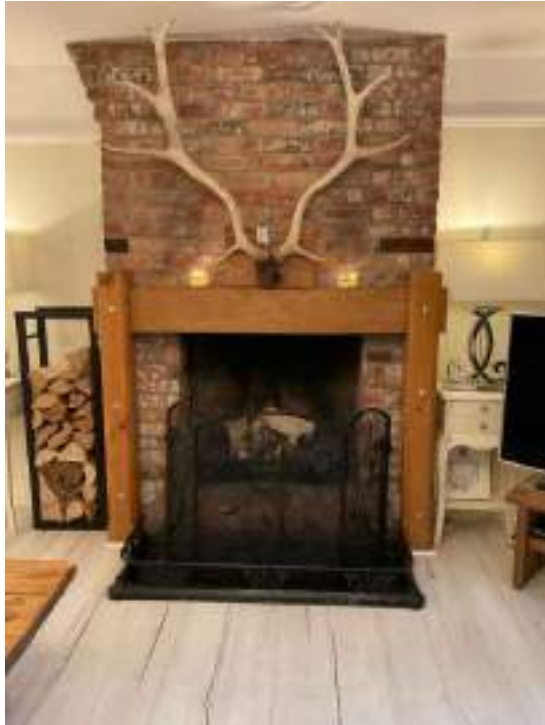
HETAS certificate required

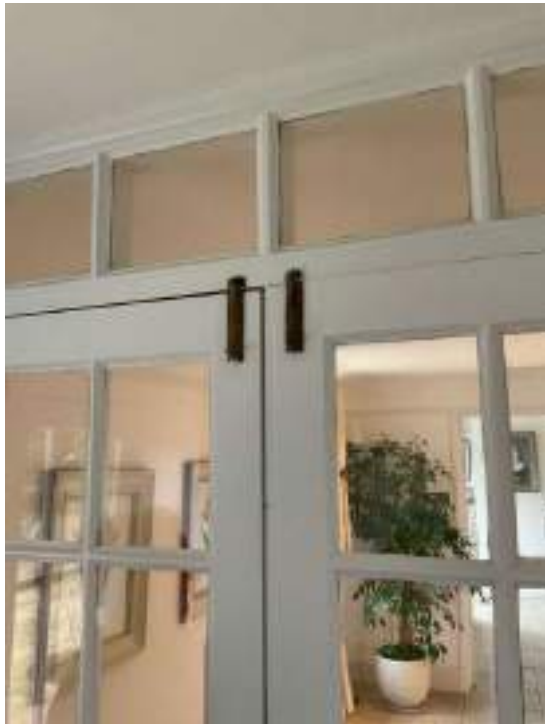
Stiff doors and no safety glazing stamps to internal doors

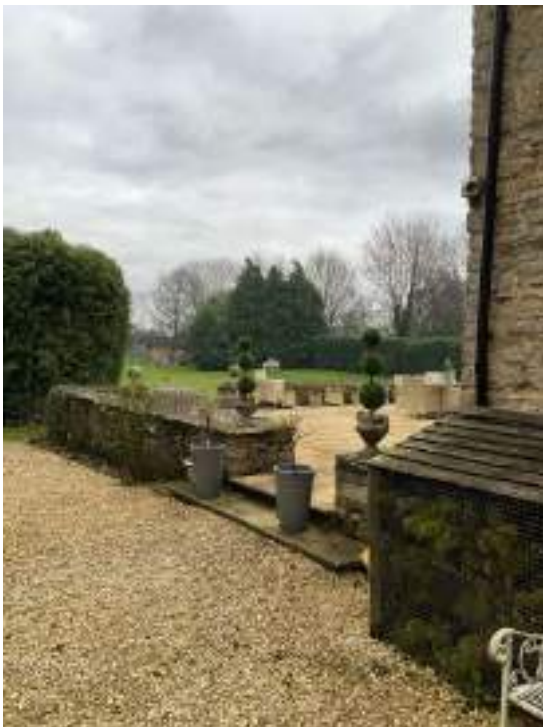
Grounds well kept
